A REVIEW OF TRUCK FIRE CAUSATION

P. M. HART
Chairman ARTSA, and
Principal of Hartwood Consulting Pty Ltd,
Melbourne, Australia.
pmhart@hartwood.com.au

This paper reports on common causes of fires on heavy trucks, buses and trailers. The author is professionally engaged in forensic engineering investigations, including fires. The paper gives the author's experience of nearly twenty years of heavy-vehicle fire investigations.

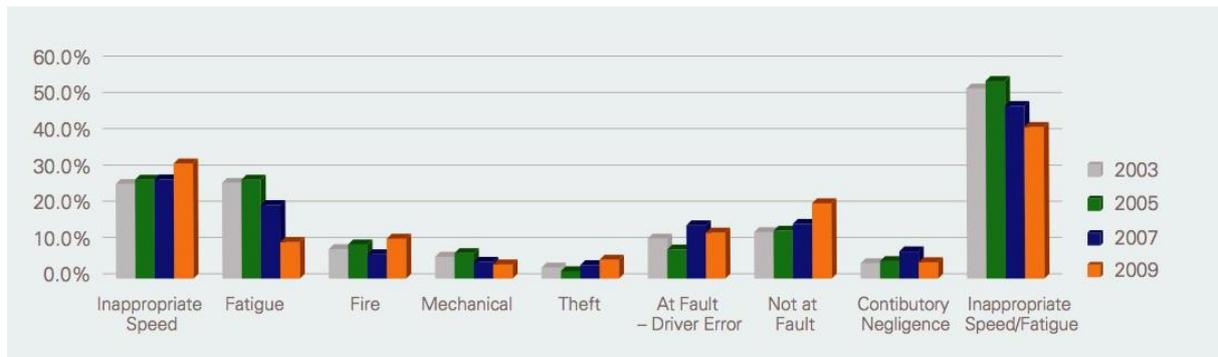
A leading Australian insurer publishes a regular review of its claims history applicable to the heavy vehicle industry. Figure 1 shows that the attribution to vehicle fires is about 8% of total fault attribution. It exceeds mechanical failure and theft as causal factors.

Figure 1 Incident cause-attribution for heavy-vehicle insurance claims (source National Transport Insurers – Australia, 2011). Note: multiple factors can apply so the totals add to greater than 100%.

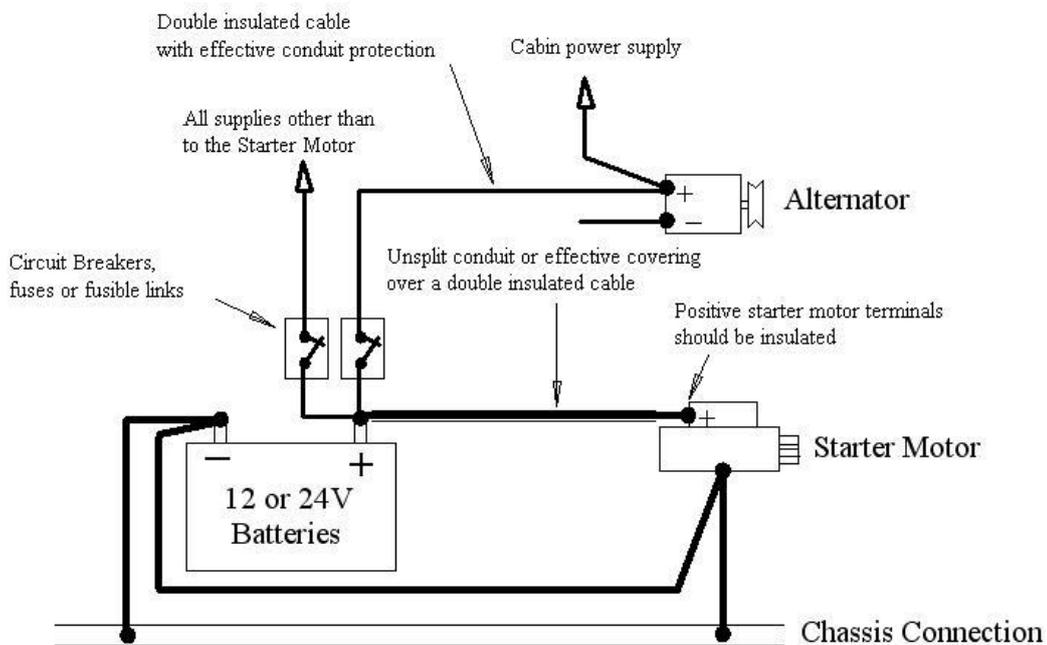
Figure 3 shows a recommended scheme with separate circuit breakers in the alternator cable and the truck supply cable. Surprisingly, many trucks do not have these circuit breakers. In time, isolation switches that include circuit breaker protection that can be disabled during cranking will be available. They are under development at present. Intelligent circuit protection will also be available. This will identify unusual or unacceptable current waveforms and turn the circuit off before the fault becomes dangerous. The trip conditions will be programmable. The issues will be inappropriate settings and reliability of the electronic circuitry that will be required in this protection scheme.

Figure 3 Elements of electrical design

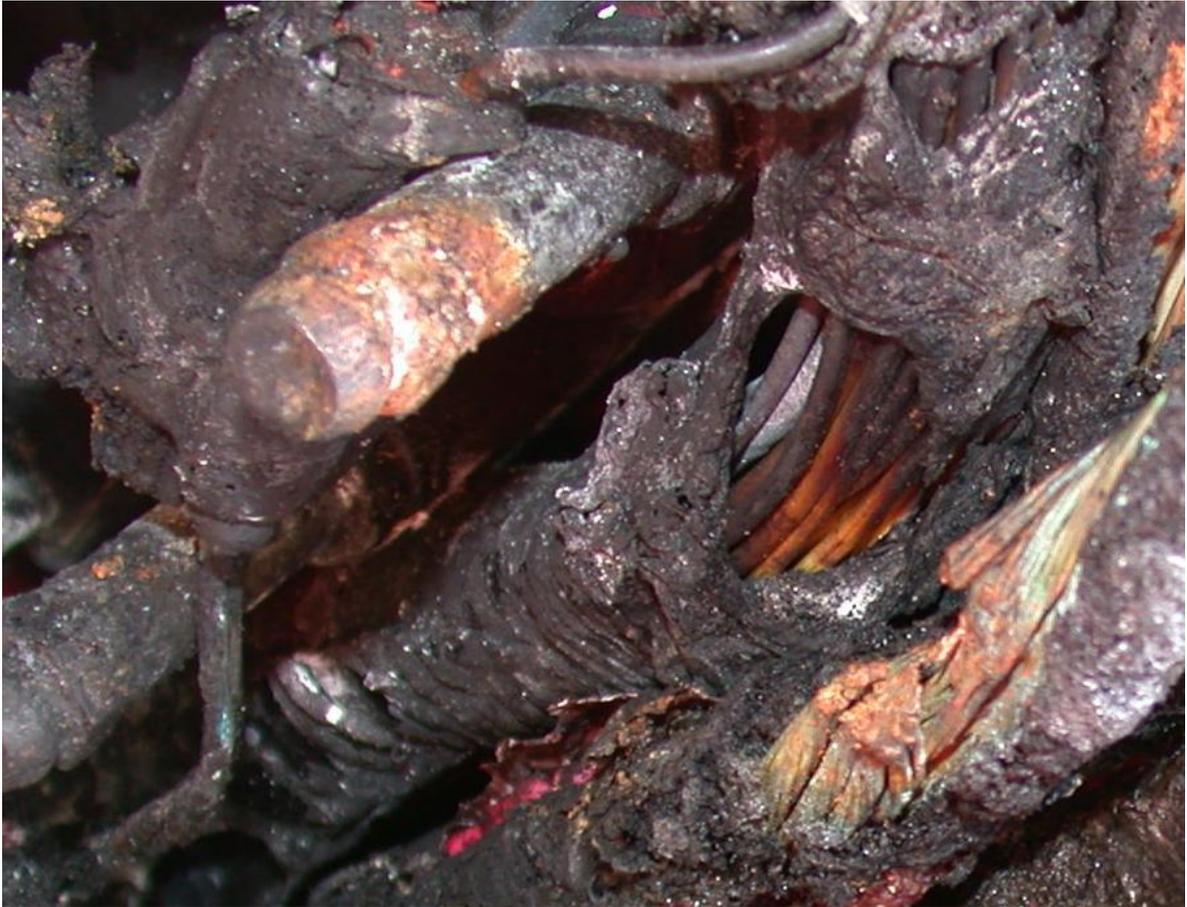
Figure 4 The result of a rub between an alternator cable and an engine stud. The alternator cable (Figure 4) was double-insulated with a split-conduit covering but the split worked its way around to the stud position. There was no circuit breaker protection at the battery end.

In the author's experience about 33% of heavy-vehicle (and passenger-car) fires occur because of insulation failure on electrically unprotected circuits. All of these could be avoided if electrical protection were provided. Most of them could also be avoided if a thorough, regular examination of cable condition were made in the workshop.

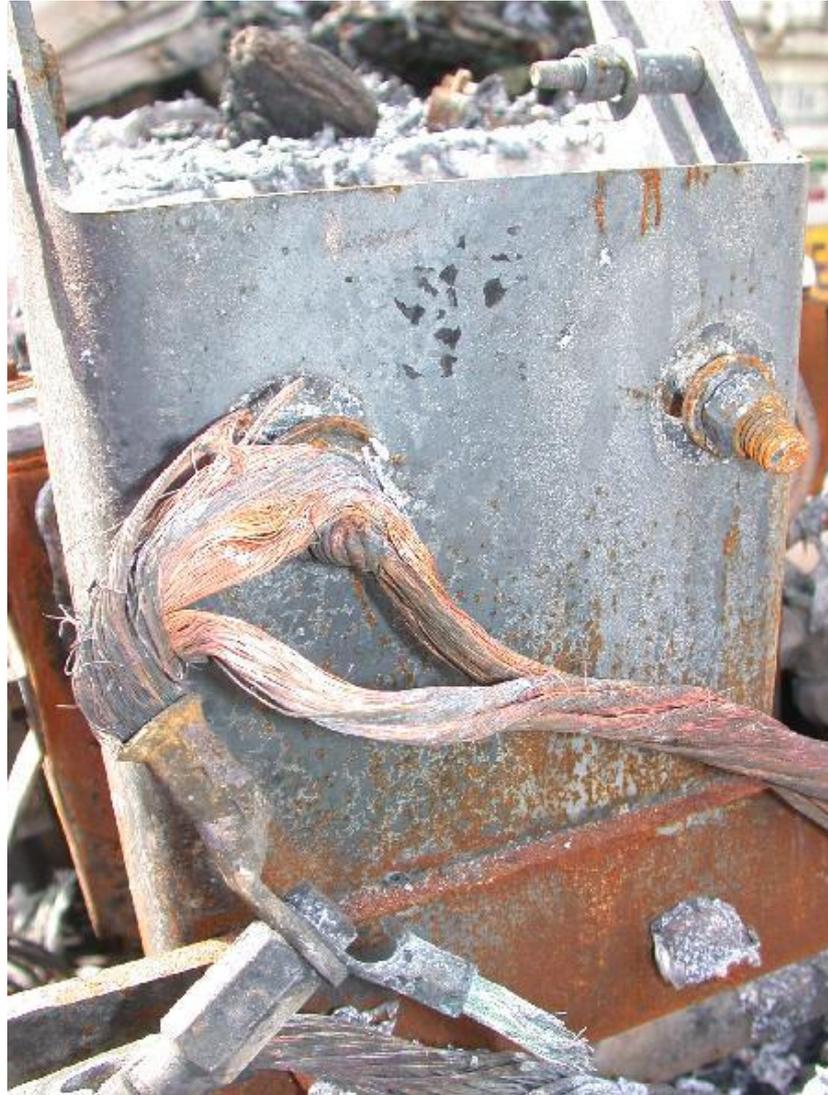
Figure 5 The result of tucking a conduited battery cable on top of an exposed threaded bolt shank inside a battery box.

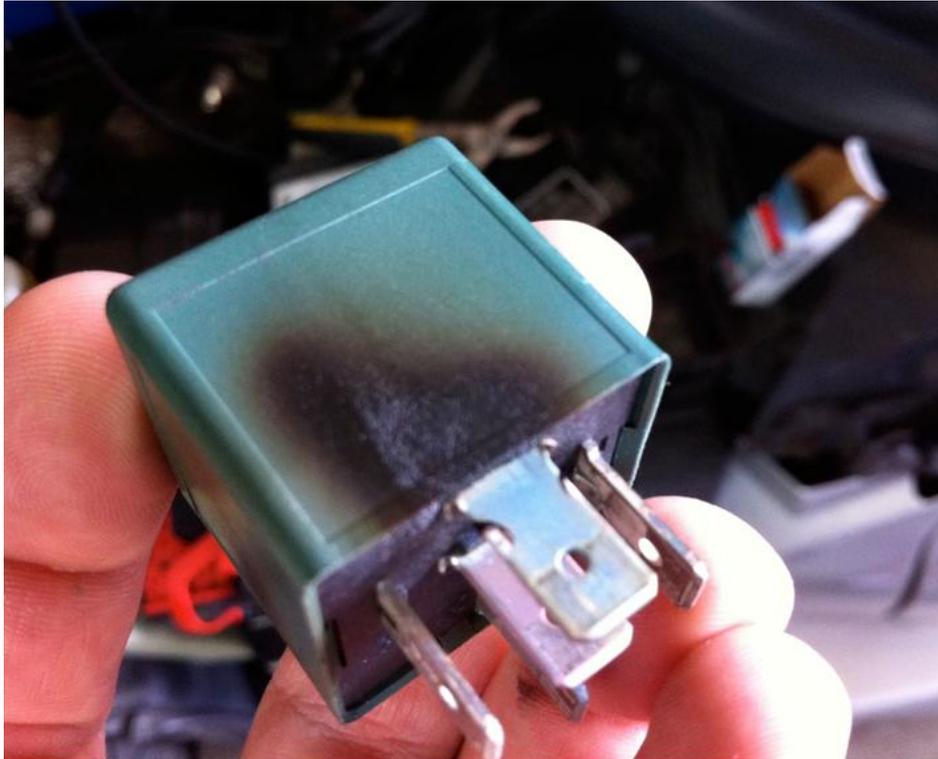
- Small wire gauge such that the copper wire struggles to absorb and transmit terminal heat.
- Road vibration combined with thermal cycling results in loose slip connections.
- Dirt getting into slip connections.
- Added loads (such as additional driving lights) that are connected to an existing heavily loaded circuit.
- Looseness.
- Contamination between mating faces (e.g. heat shrink ingress).
- Inadequate safety margin in the design.

The latter point needs further clarification. Equipment manufacturers sometimes give a current rating for terminals. For example, a 6.3mm spade terminal is often rated at 30A. Whilst this might be acceptable on a passenger car, it is unacceptable on a heavy vehicle because the conditions are more severe. As a guide the electrical-equipment manufacturer's current ratings should be halved for truck service!

Figure 6 Overheating of a cube relay has resulted from a hot terminal. The plastic case is distressed.

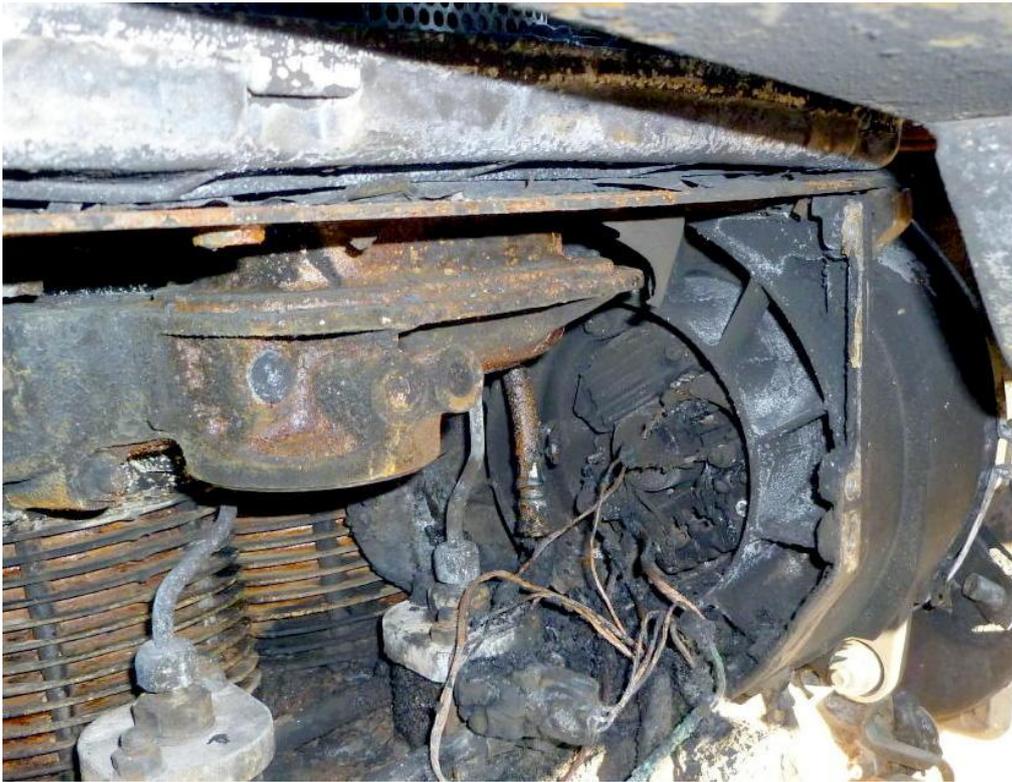
Organic dust (such as agricultural dust) is flammable and mildly conductive if it is wet. If organic dust settles onto live electrical parts, a 'high-impedance' electrical fault can occur. The fire mechanism is current flow through the dust that causes heating and eventually results in carbonization. Once carbon is present, the current level increases as does the heating potential. If the electrical circuit is battery powered, the fault can occur when the vehicle is parked.

Figure 7 Fire resulting from a shorting through agricultural gain dust inside an alternator (on a trailer blower motor).

Alternators are vulnerable to this fire cause because they have live internal circuits and air-cooling grills that allow dust in. Electrical equipment that is open to atmosphere so as to provide cooling, should be regularly blown out with compressed air.

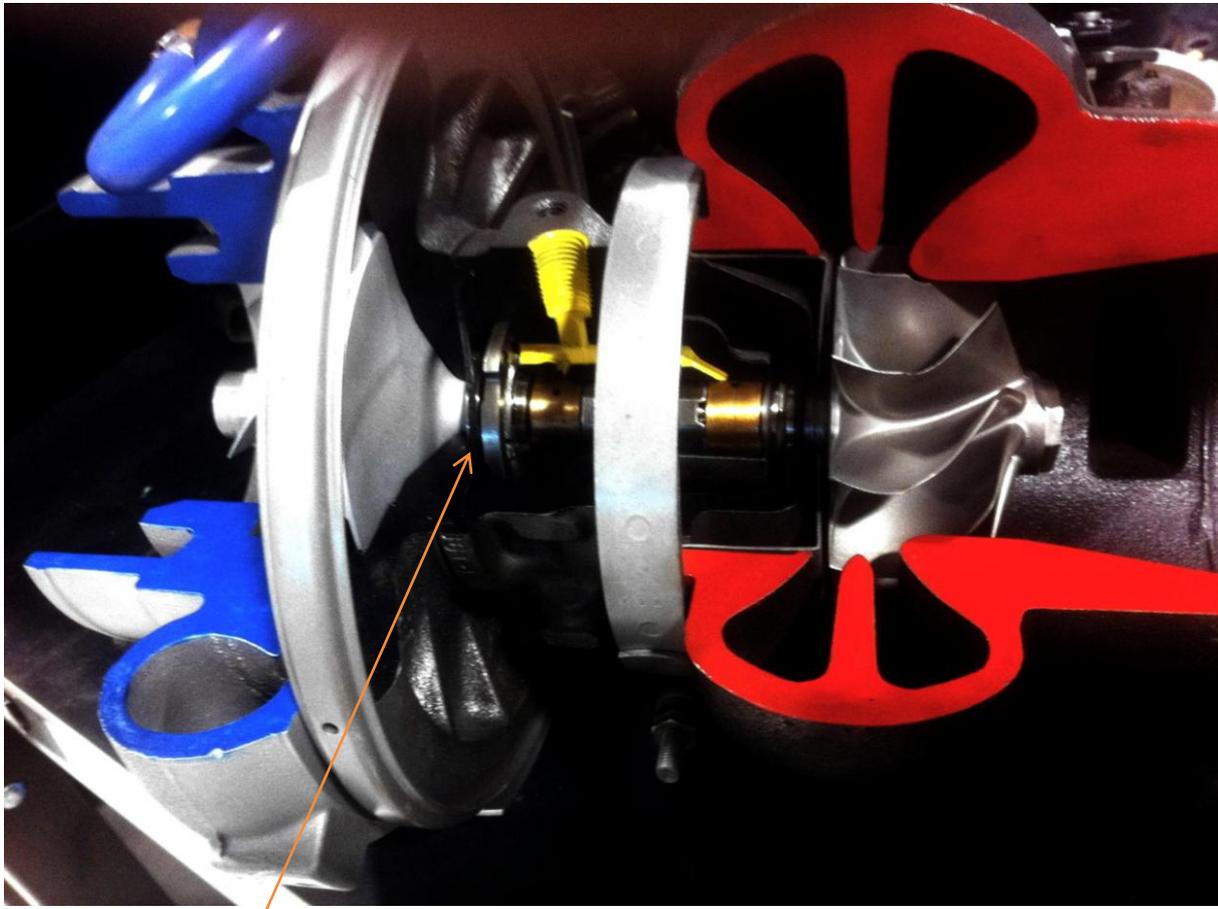
In the author's experience fires occasionally result from turbocharger failure because the rotor oil seals on the air intake side are damaged by the blade failure and an oil-fed fire occurs on the air-intake side of the turbocharger. Truck turbocharger bearings are invariably lubricated and cooled by forced engine-oil flow. If the oil seals fail on the exhaust side, a fire will occur in the exhaust pipe. However, the exhaust pipe is designed to withstand high temperatures so an external fire is unlikely to occur. If however, the oil seals on the air-intake side fail, oil might be pumped into the air intake side. Should this oil catch fire, the internal fire will probably get out by burning through a rubber elbow, or maybe through an aluminum tube.

Figure 8 shows a demonstration turbocharger. With the air-boost side oil seal indicated. This is the vulnerable oil seal. Should a fire occur in the exhaust side as a result of seal failure, which is possible, the fire might spread to the air intake side if the bearings and oil seals are damaged. Drivers should be instructed to not drive a vehicle that has a failed turbocharger because subsequent destructive failure of the bearing assembly could result in a vehicle fire.

The oil seal on the air-intake side

Figure 8 The oil seals and lubrication ports are evident in this photo of a sectioned turbo-charger.

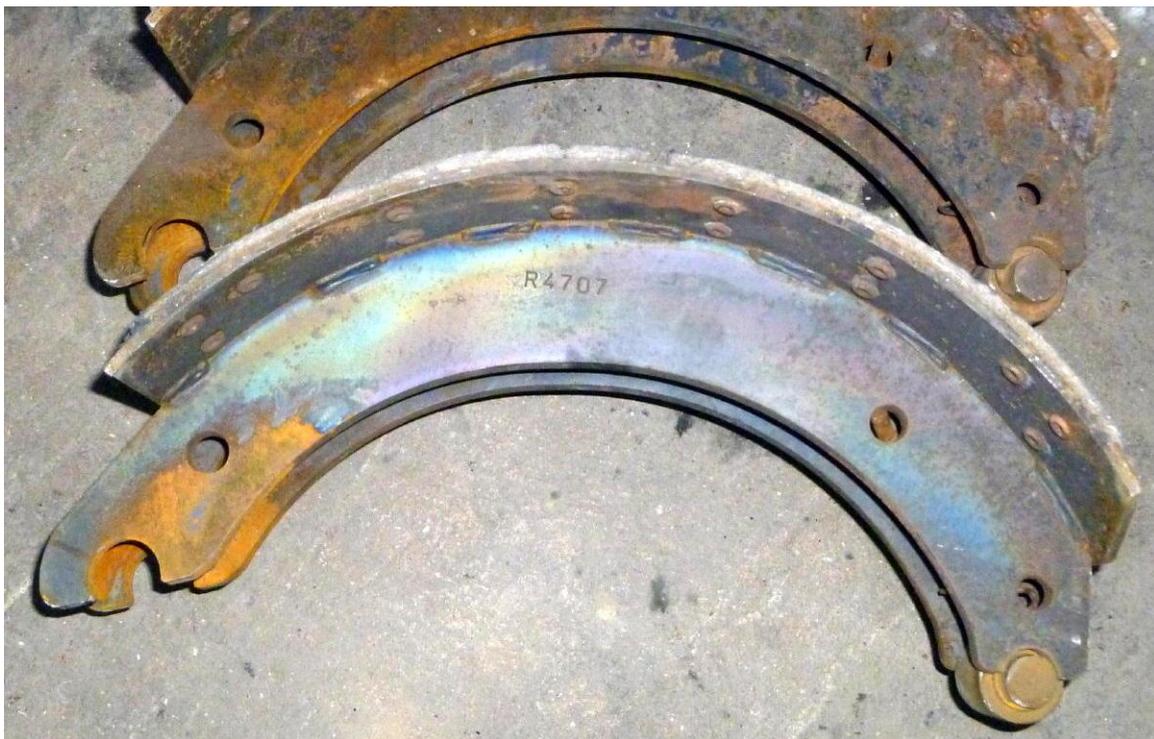
Very poor brake balance occurs when the brakes on one vehicle in a combination are in poor adjustment or sometimes when one vehicle has disk brakes (with automatic adjustment) and another vehicle has drum brakes (without automatic adjustment).

Figure 9 Poor brake balance resulted in hot brakes on one side of a trailer axle. The brake drum became so hot that the tyre caught fire.

Drivers should walk around the vehicle after it is stopped to check the brake temperatures. Very hot brakes smell. They are easy to identify close-up.

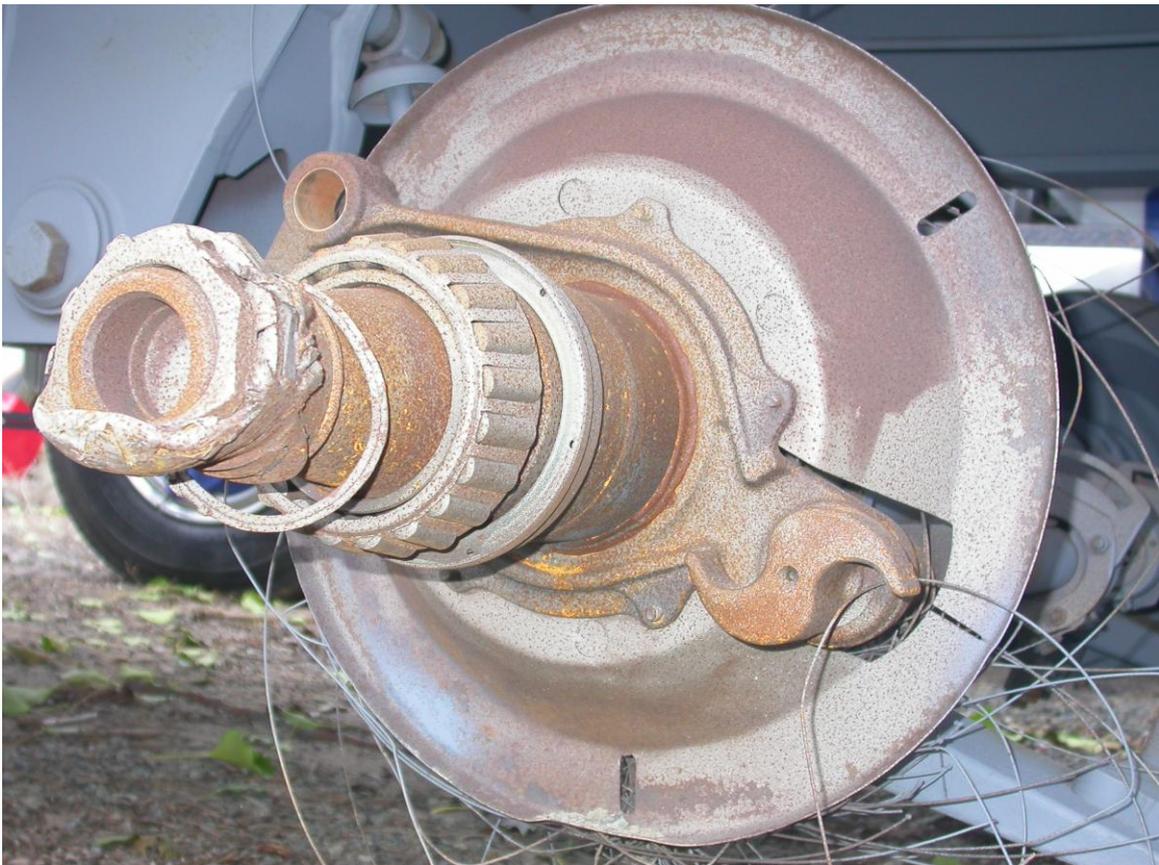
Excessive wheel bearing temperatures can result from mechanical failure of one of the two wheel bearings. The precursor to this is likely to be poor lubrication. As mentioned previously, dragging brakes may result and this might lead to fire. The fire mechanism is that the brake grease catches fire.

Figure 10 Poor lubrication of the outer bearing on a trailer axle resulted in extreme bearing temperature. The steel softened and flowed.

Regular lubrication according to manufacturer's recommendations is essential for satisfactory bearing life. There are some drive-axes for which the bearings are lubricated by oil over-flow from the differential. If the serviceman does not know how to cause the overflow, poor lubrication and fire might result. Regular scheduled maintenance of wheel bearings is

essential to prevent failure and possibly fire. Temperature indicating strips affixed to the axle hub can be useful. Drivers should ‘feel’ for elevated axle temperatures during trip inspections.

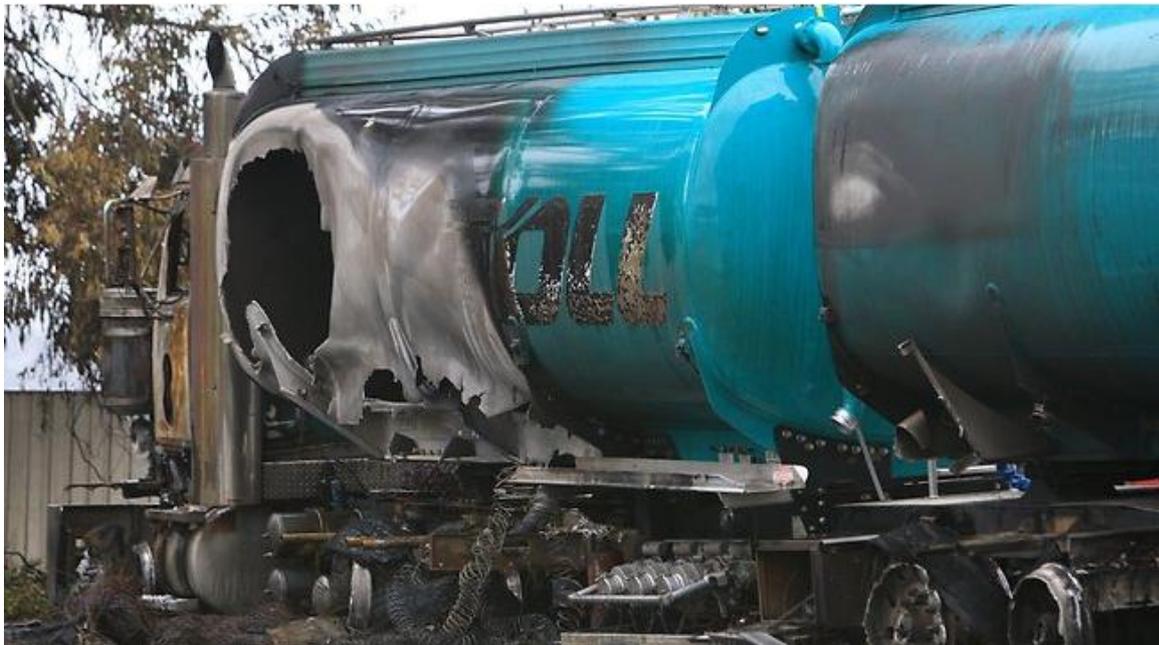
The auto-ignition temperature of diesel fuel is about 260°C. The external temperature on the turbocharger exhaust casing might be 450°C and on the exhaust pipe 500mm from the turbocharger, 350°C. Diesel fuel vapour will explode if it contacts the exhaust pipes near the turbocharger. Usually the fuel lines are kept well away from the exhaust pipe to minimize the risk from fuel leakage, but the exhaust pipes of a dual-exhaust system will probably run behind the engine and may come close to the return fuel lines.

Figure 11 Hot exhausts produce significant risks for petrol tankers.
