Transverse Cracking Distress and Vertical Dynamic Impact Load From Heavy Truck Axles - A Feasibility Study

George J. Chong
Research and Development Branch

Ministry
of
Transportation

Research and
Development
Branch

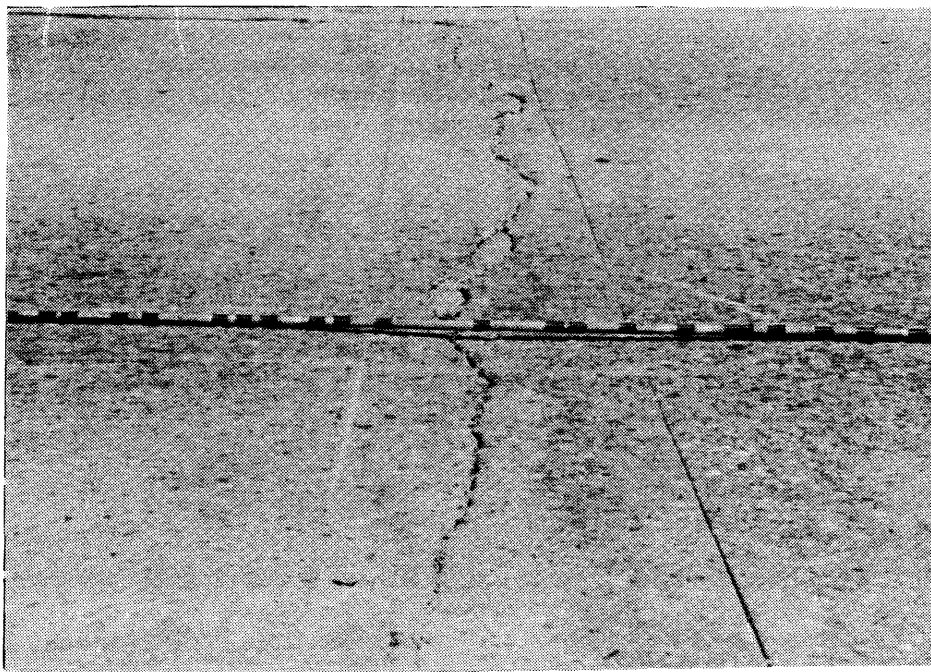
Transverse cracking, if left untreated, will develop into more drastic distresses such as multiple cracking, spalling and potholes, deformation, and even structural failure. These distresses are irreversible and are a major factor in pavement surface roughness. The most undesirable distress characteristic of a transverse crack is the permanent deformation commonly known as cupping. Cupping is described as a depression of the pavement profile at the transverse crack (Figure 1).

Figure 1/ Cupping (Depression) at Transverse Crack

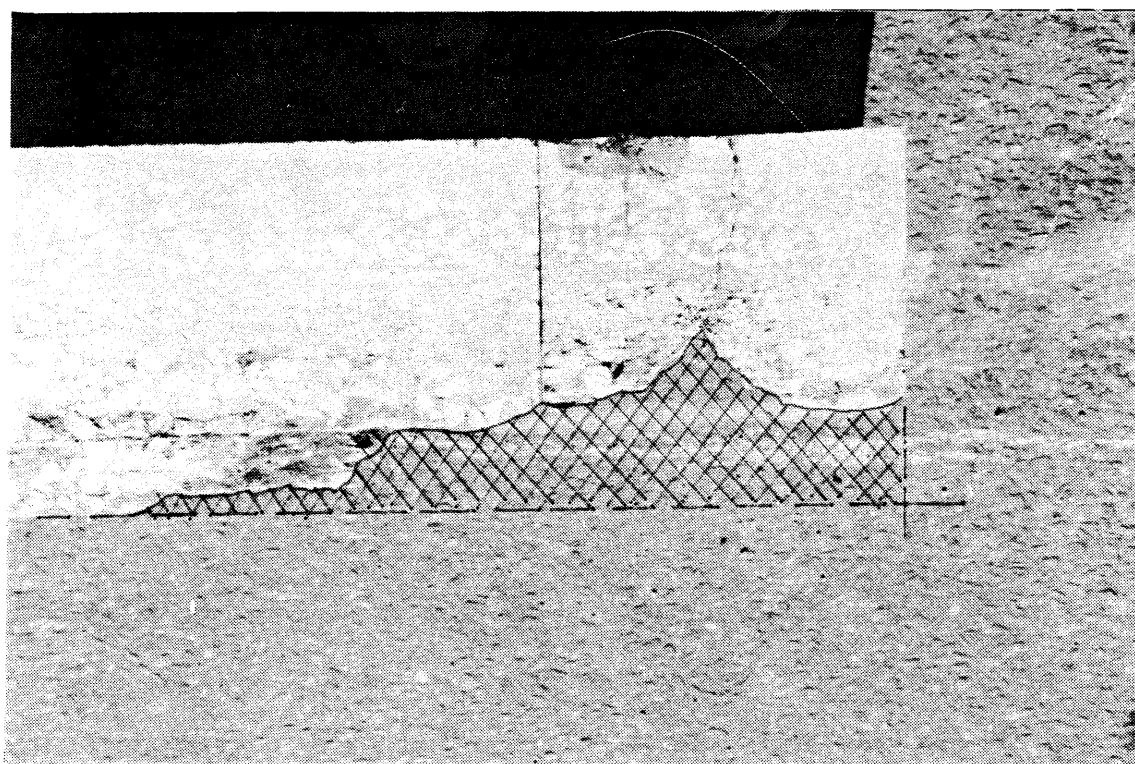
On-going investigation shows that transverse crack cupping is caused by internal deterioration which usually takes place at the bottom of the asphalt layers and progresses upward [1] [2]. In the case of a heavily travelled highway, this internal deterioration can result in half or more of the original asphalt layers disintegrating into loosely bonded materials from the bottom upward, resulting in a depression at and about the transverse crack (Figure 2).

Figure 2/ Internal Deterioration at Transverse Crack (300 mm total thickness, 150 mm disintegration at crack. Extension approximately 1 m fore and aft.)

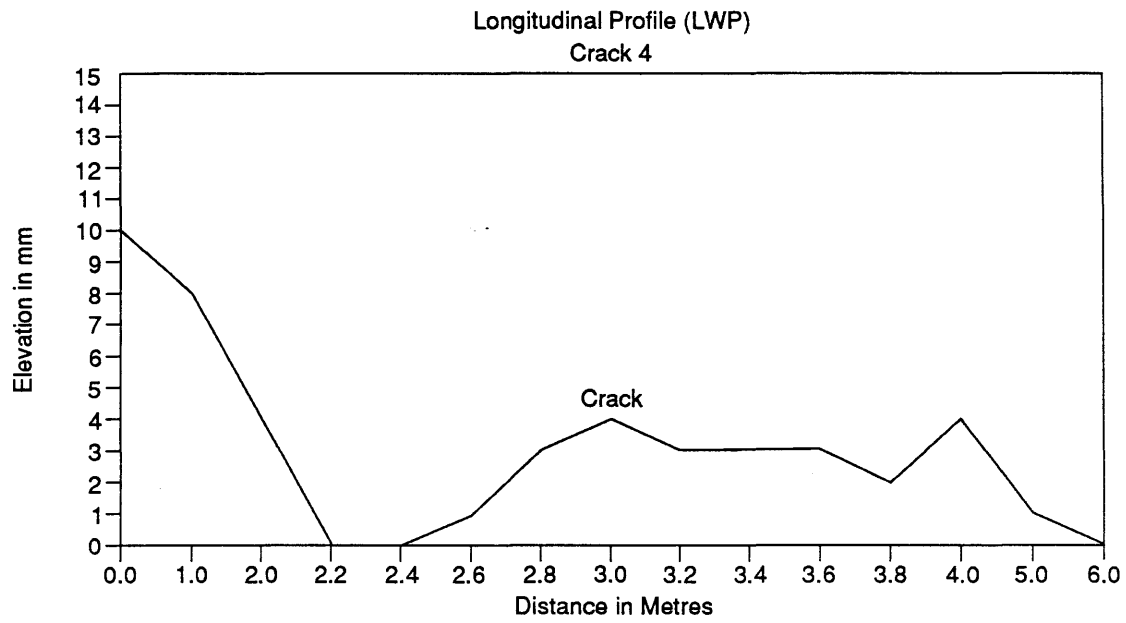
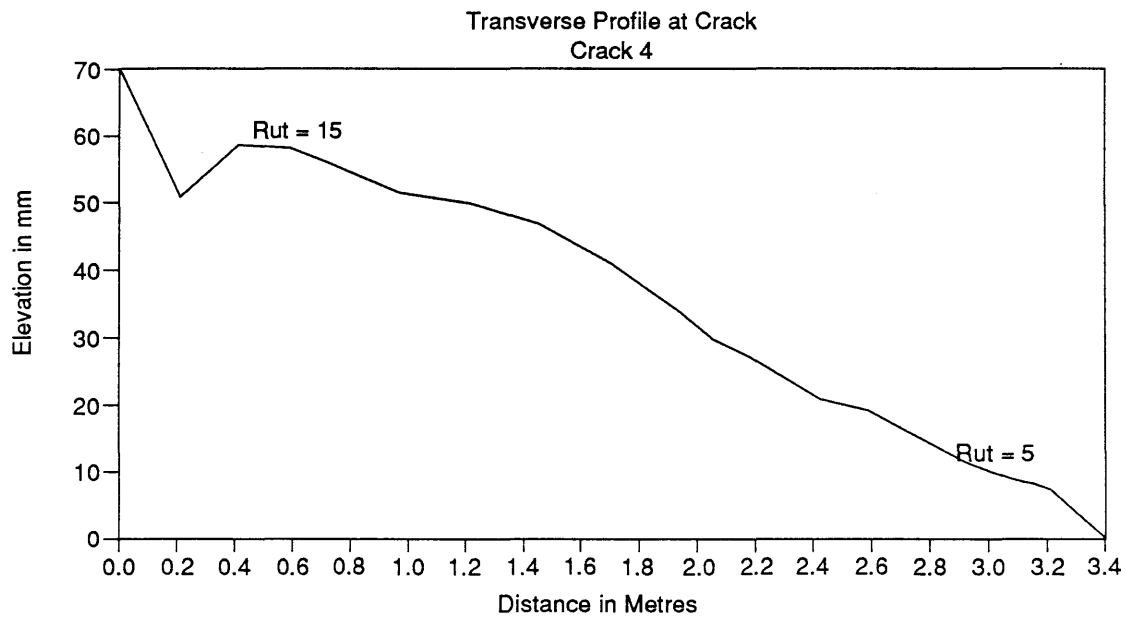
- The left wheel path longitudinal profile and the transverse crack transverse profile were obtained with precision levelling. The resultant rut depth measurements at the transverse cracks are tabulated in Table 1. Representative profiles from Test Cracks No. 4, 7, and 9 are presented in graphic form (see Figures 5 to 7).

Figure 5/ Profiles of Test Crack No.4 (Rating: Slight)

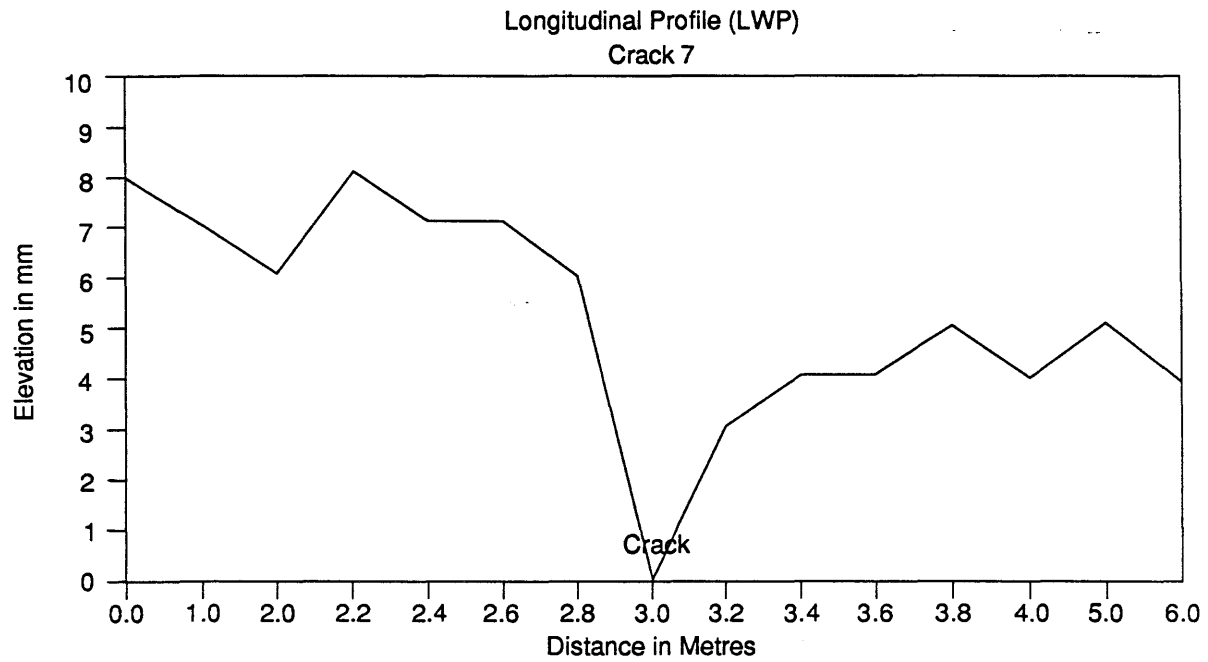
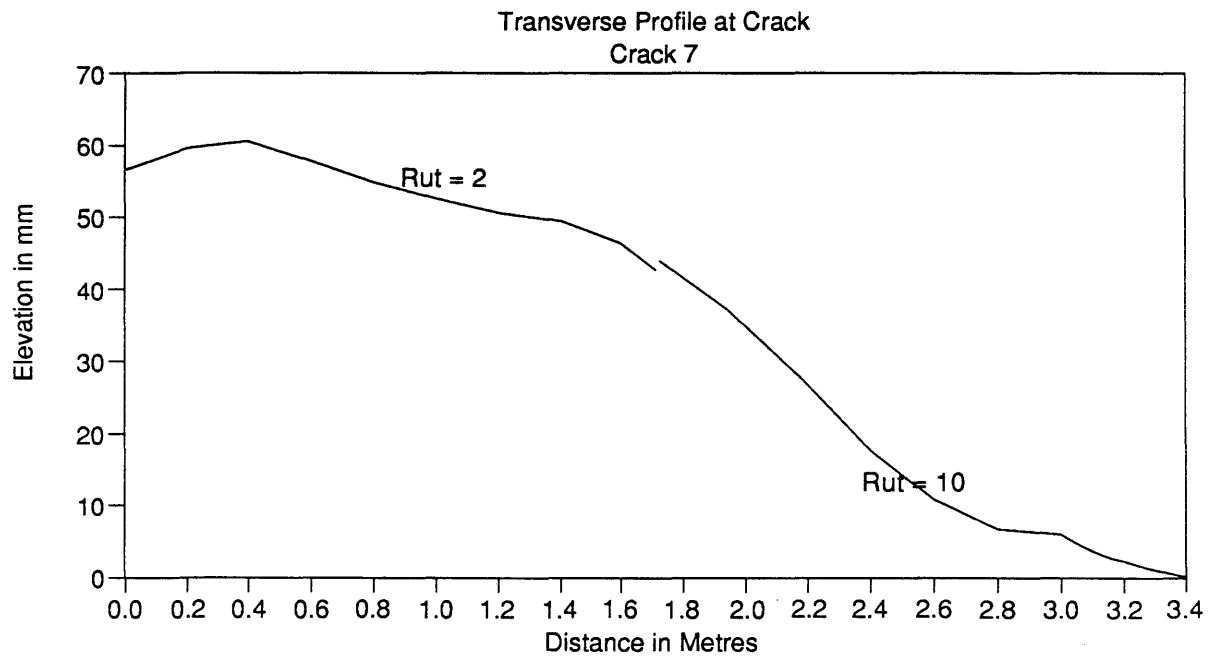
Figure 6/ Profiles of Test Crack No.7 (Rating: Moderate)

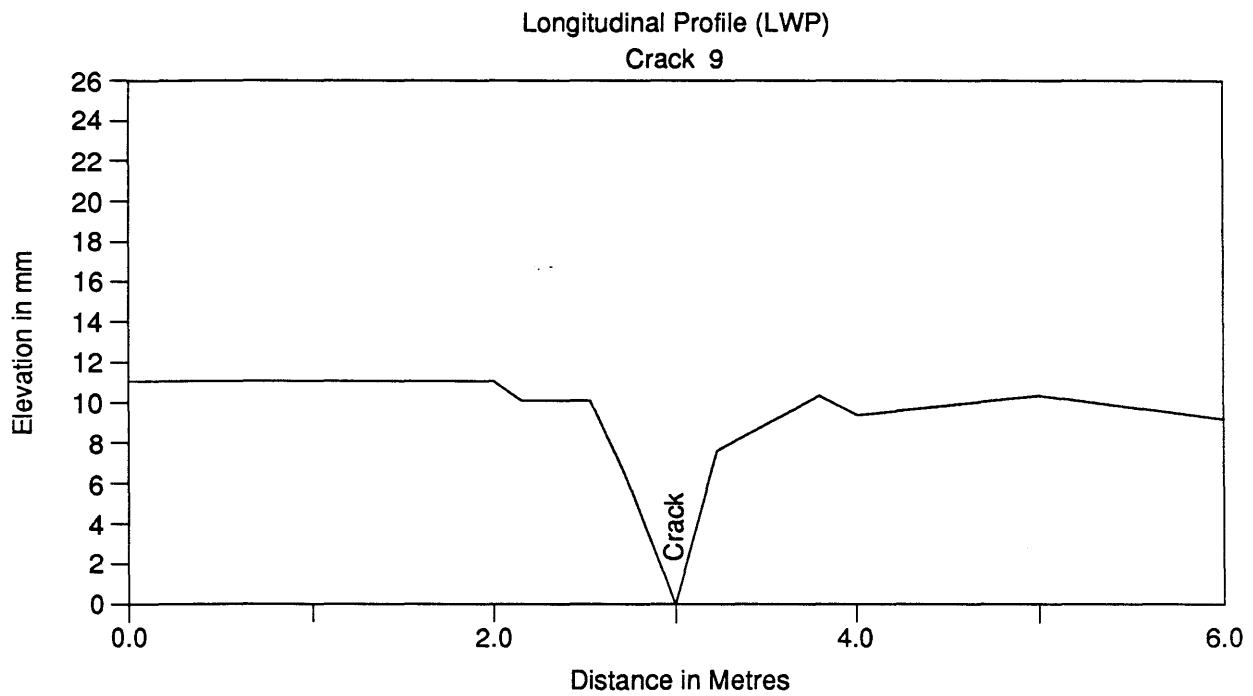
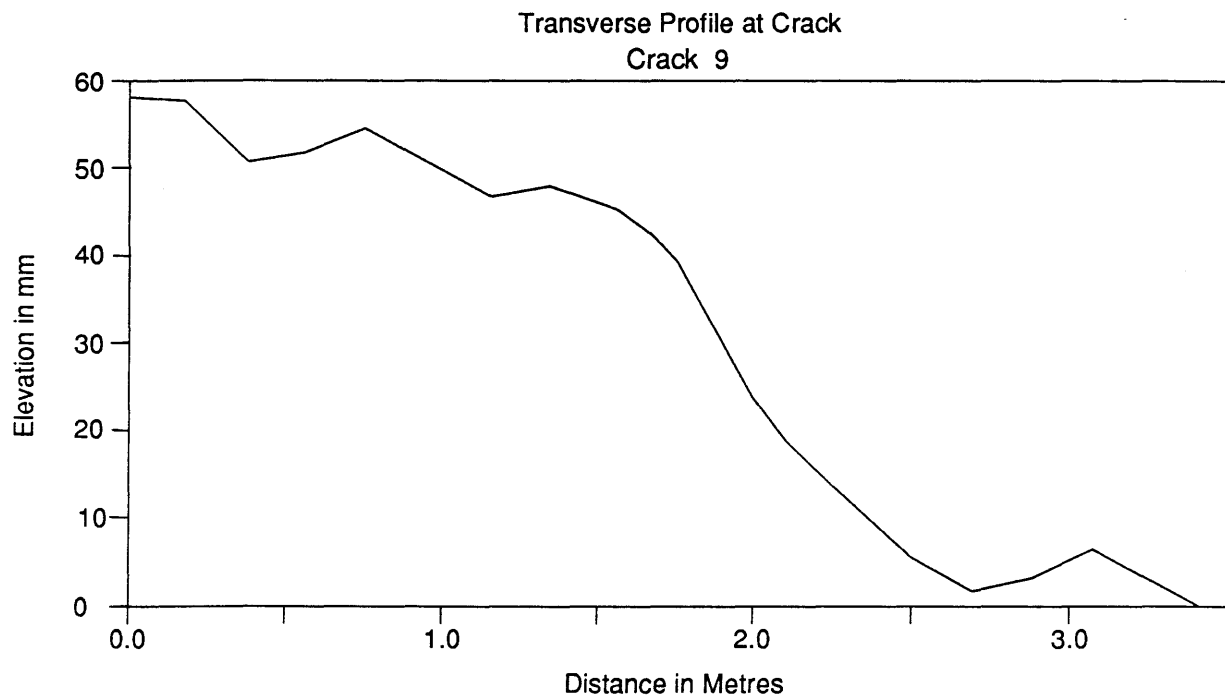
Figure 7/ Profiles of Test Crack No. 9 (Rating: Very Severe)

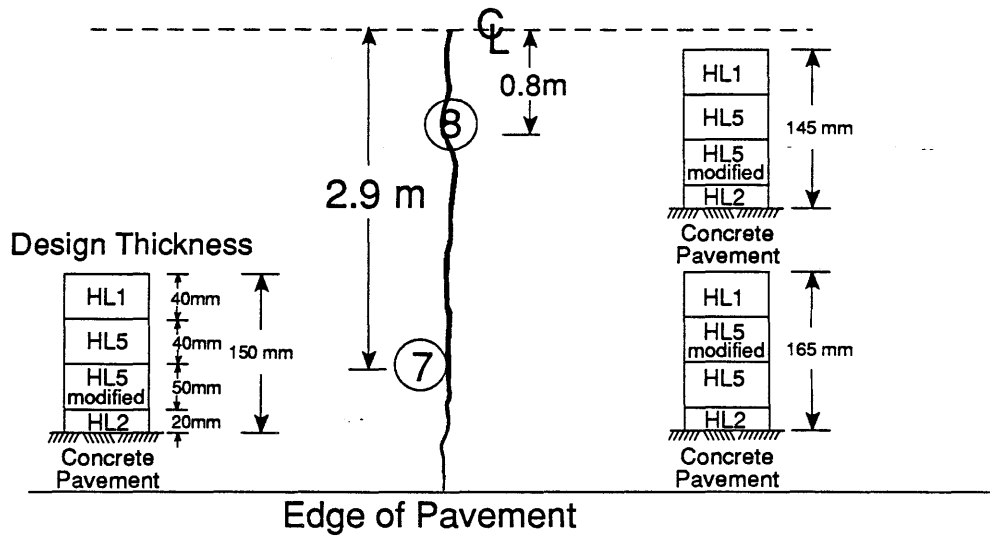
Figure 8/ Core Investigation Of Test Cracks No. 4, 7 and 9

The core investigation results (Figure 8) and the measured longitudinal profiles of the cupped transverse cracks related quite well. Where there is no deterioration in the asphaltic layers, cupping is only slight or nonexistent (Figure 13). On the other hand, if the asphaltic layers had deteriorated drastically (Figure 8), the cupping was observed to be moderate to severe (Figures 14 and 15).

Crack No. 4
Rating: Slight

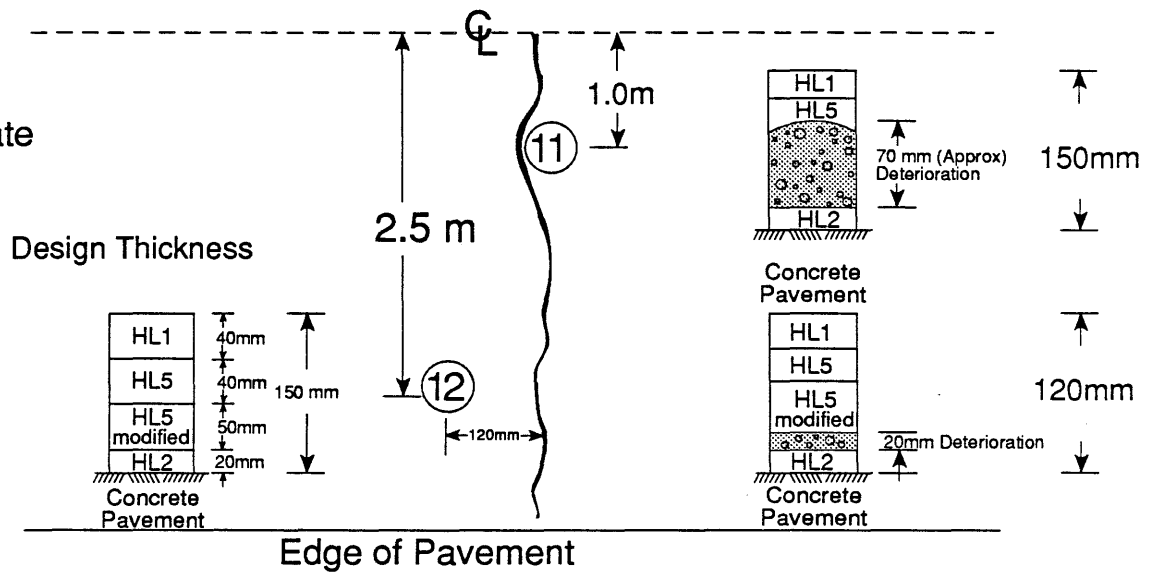
Crack No. 7
Rating: Moderate

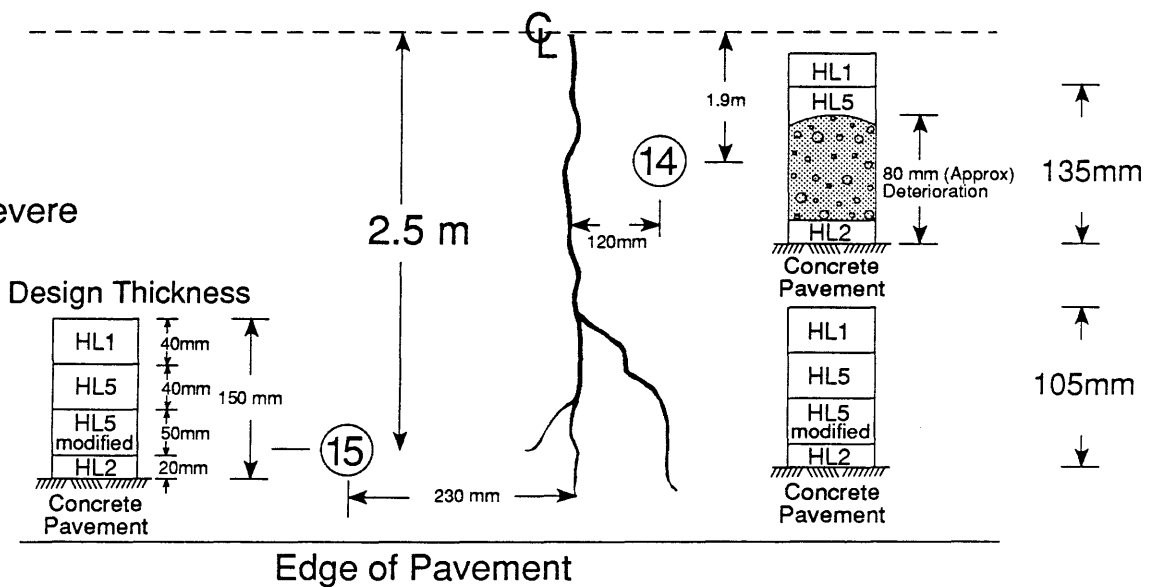
Crack No. 9
Rating: Very Severe

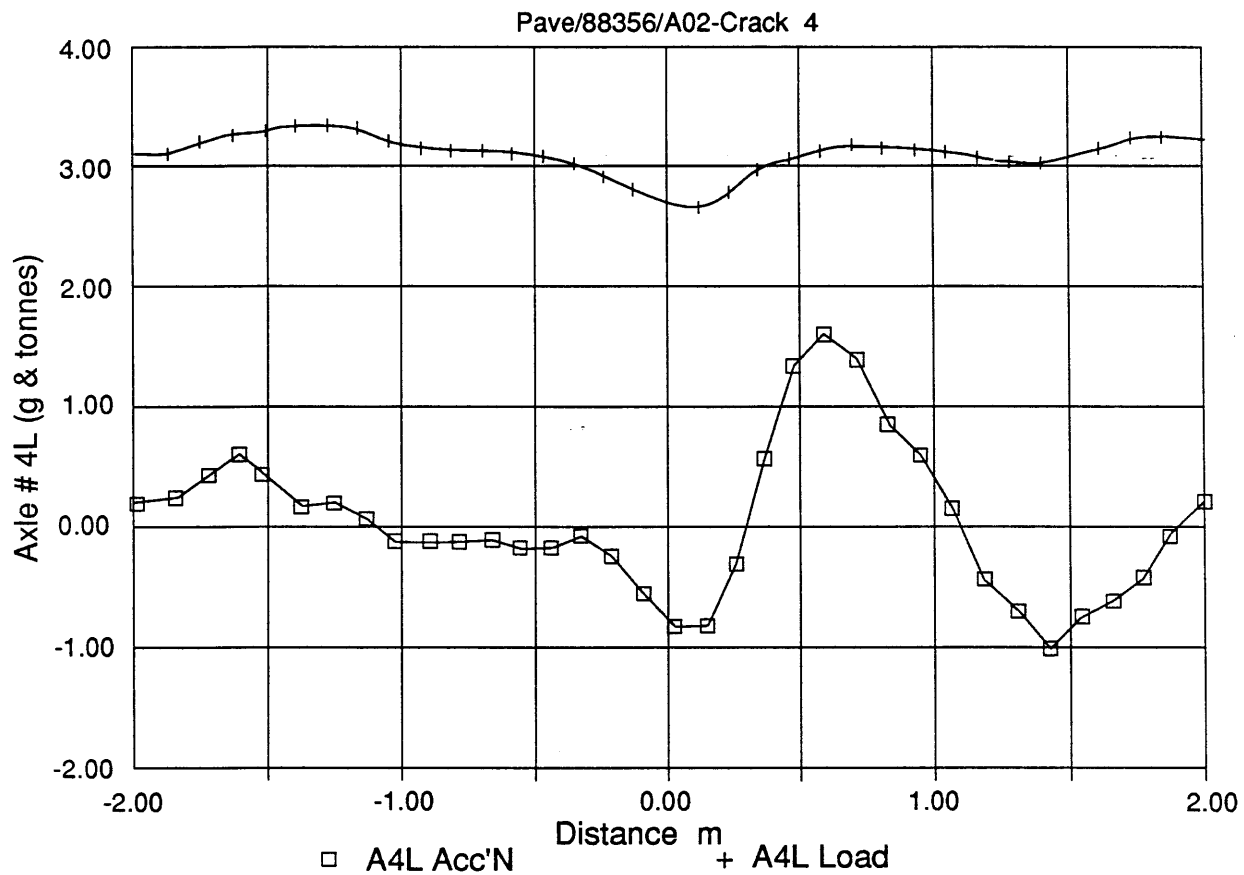
Figure 9/ Crack Study, 401 W/B, Belle River to Puce Rd

Inspection of graphs Figure 9, crack 4, (slight); Figure 10, crack 7 (moderate); figure 11, crack 9 (severe); Figure 12 (smooth road) and Table 2, show that there were distinct differences between slight and severe cracks (cupping). Those described as slight by the core and visual survey, exhibited an initial negative or downward acceleration of approximately -1.0 g followed by a positive or upward acceleration of up to 1.6 g. Moderate cracks had slightly larger downward values and positive accelerations of up to 1.9 g. Severe to very severe had upward values between 2.0 and 4.0 g respectively. Smooth road conditions had values between +/- 0.5 g. In all cases cupping was characterized by a negative followed by a positive axle acceleration.

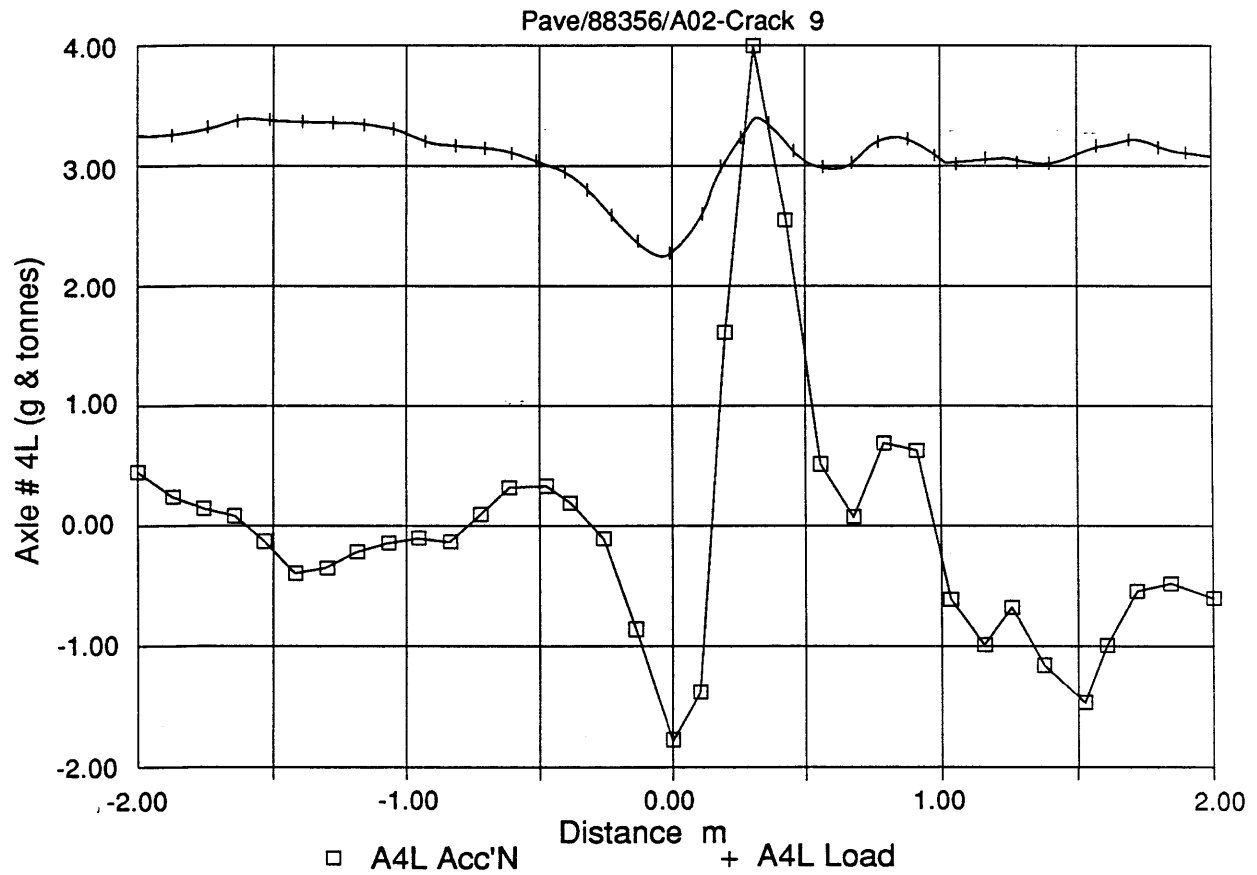
Figure 11/ Crack Study, 401 W/B, Belle River to Puce Rd

From the data gathered during this preliminary test, it would appear that axle vertical acceleration may be the best indicator of the severity of cupping. A threshold set at +2.0 g would separate the slight to moderate cracks from the severe.

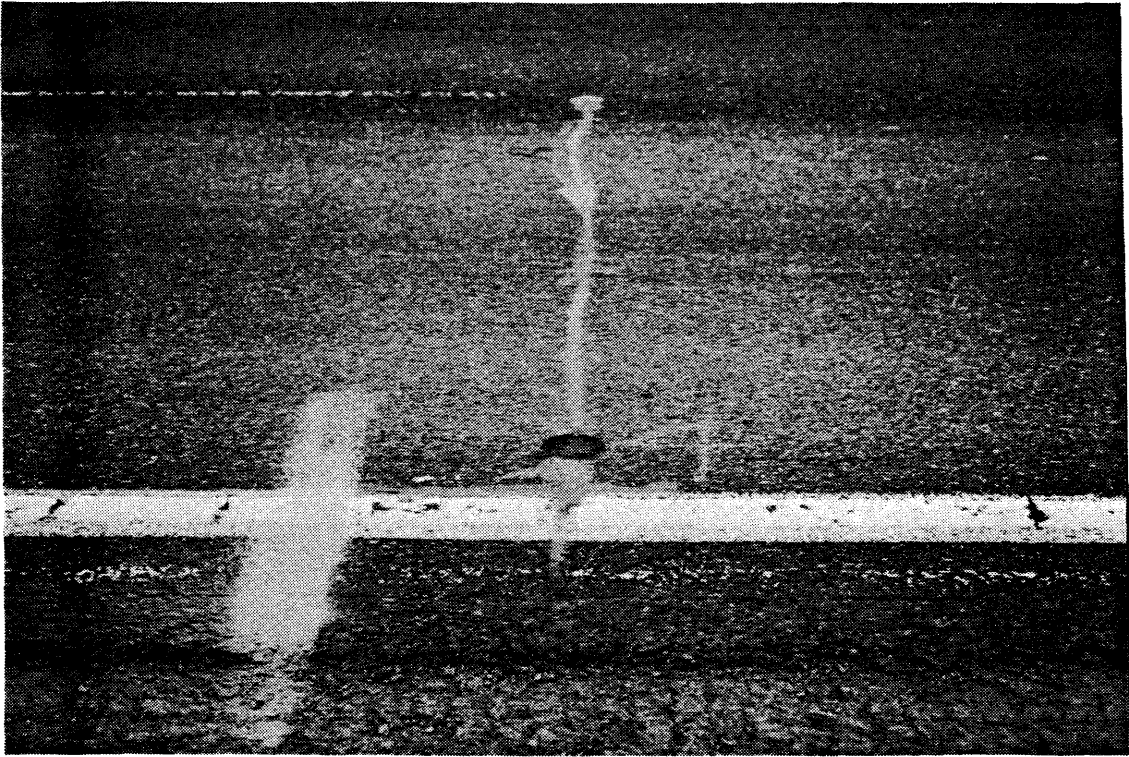
Figure 13/ Test Crack No. 4
Regional Classification: Slight Cupping Distress

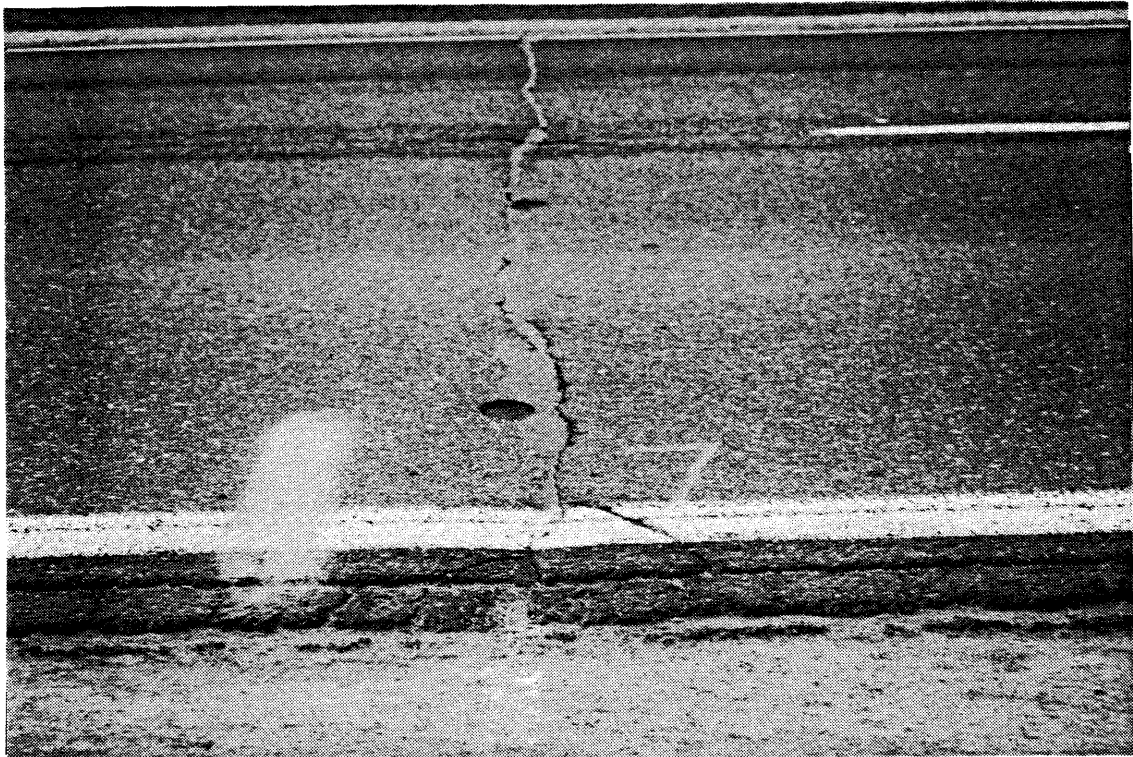
Figure 14/ Test Crack No. 7
Regional Classification: Moderate Cupping Distress

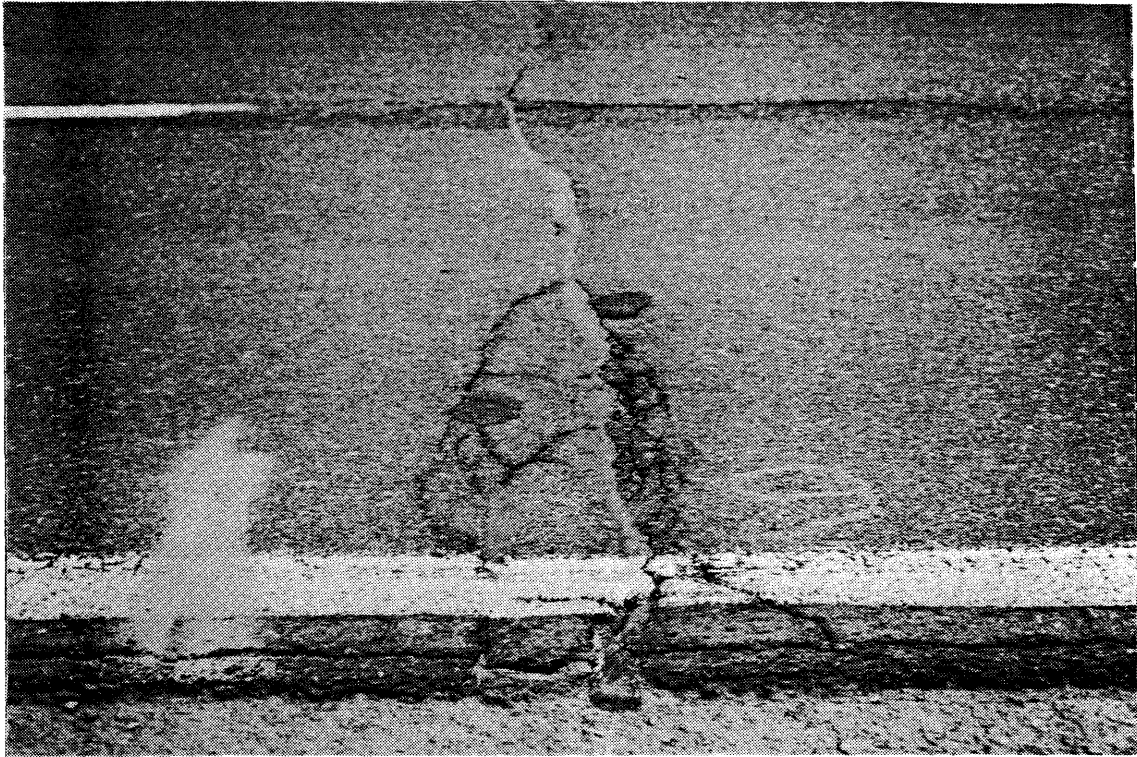
Figure 15/ Test Crack No. 9
Regional Classification: Very Severe Cupping
Distress
