THE EFFECTS OF SAFETY CHAINS ON THE DYNAMICS OF TRUCK AND DOG TRAILER COMBINATIONS IN THE EVENT OF A COUPLING FAILURE

ABSTRACT

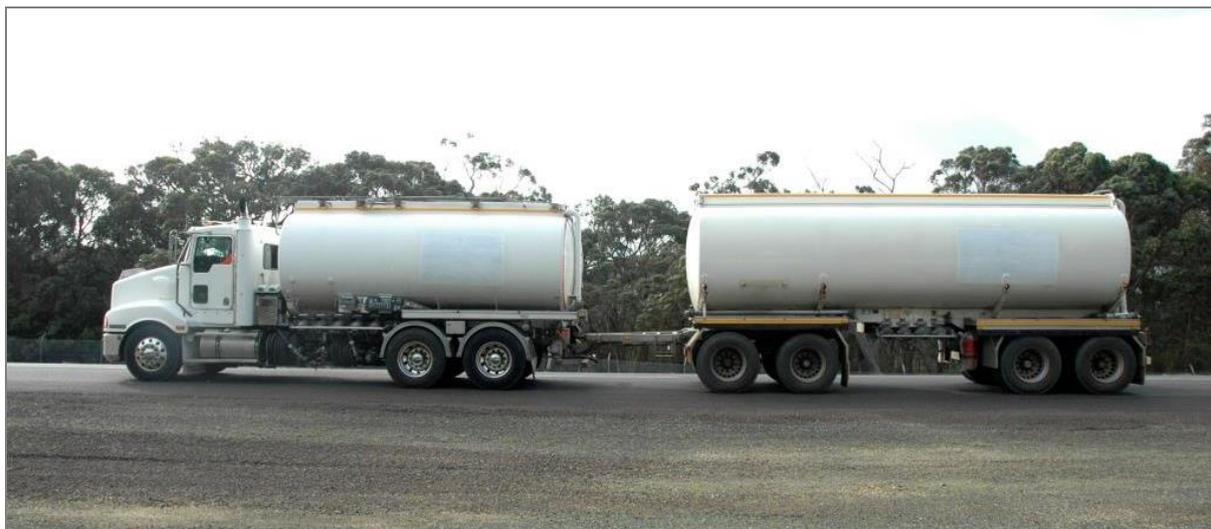
The transport company provided a representative truck and dog trailer for use in the field tests. It comprised a three-axle straight truck and a four-axle trailer, both fitted with tanker bodies (Figure 1). The truck was fitted with a new pin-type coupling, featuring a unique remote release mechanism installed by the transport company’s maintenance contractor. The mechanism allowed the pin coupling to be disengaged by activating a switch located within the truck cabin, which could be done while in motion. The coupling was also fitted with two 780 mm long safety chains manufactured and installed by a reputable local supplier (Figure 2). The chains were crossed underneath the coupling, as recommended by the supplier, to support the drawbar and also to limit lateral movement.

FIGURE 1 – Test vehicle

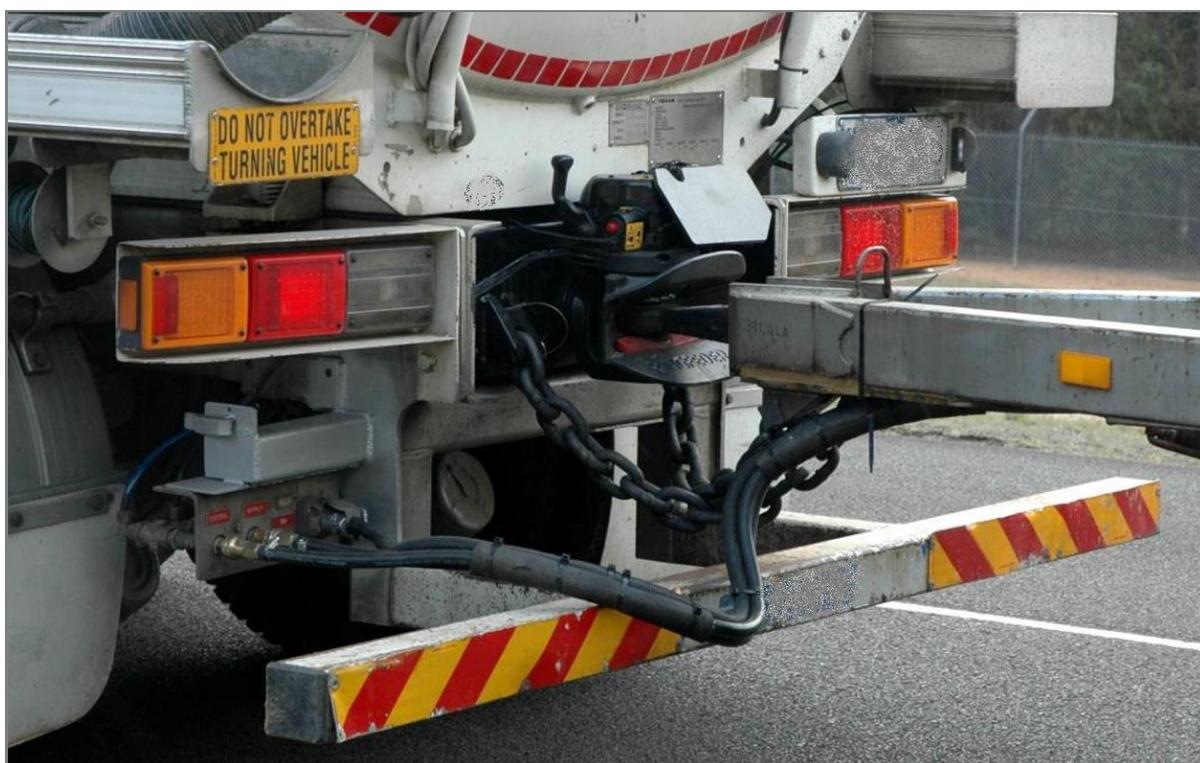
FIGURE 2 – Pin-coupling, release mechanism and safety chain arrangement

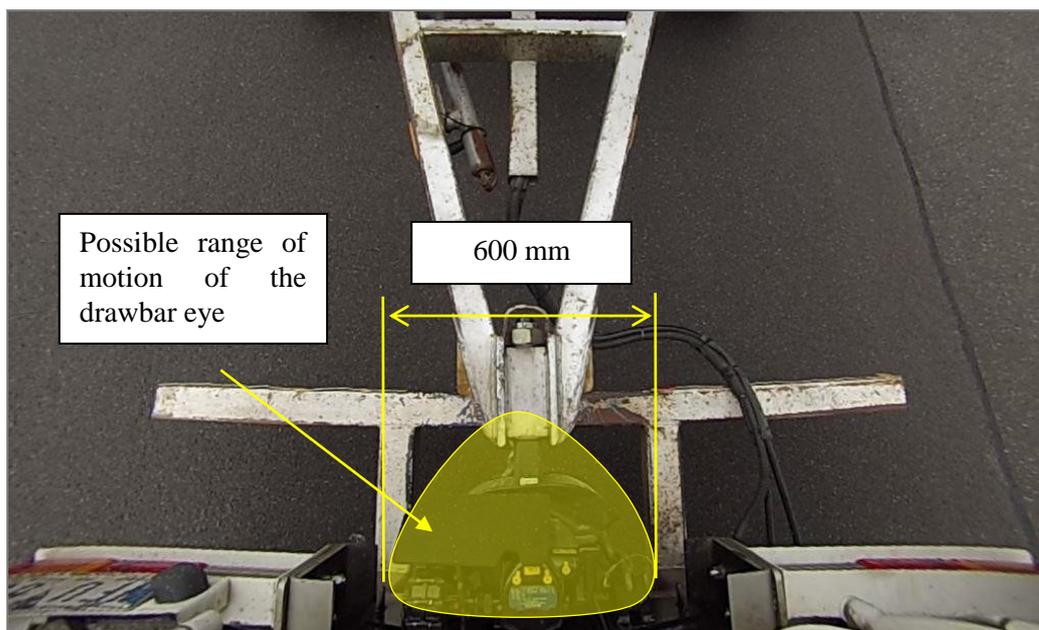
At 20 km/h the trailer was observed to slightly ‘wander’ laterally (i.e. from left to right on the roadway), when the chains were slack. The extent of lateral movement in all cases was limited by chain length and the location of the chain attachment points, such that the range of motion of the drawbar eye resembled an irregular shape, approximated in Figure 3.

FIGURE 3 – Observed possible range of motion of the drawbar eye

The key finding was that when un-coupled, the drawbar eye had a limited range of motion within the constraints of the chains, which permitted the trailer to alternately push and pull the truck while driving, and to sway from left to right on the roadway. Neither the fore-aft shunting, nor the left/right wandering affected the handling or dynamic behaviour of the truck in an unsafe manner, nor did it reduce the level of control that the driver had over the truck in terms of steering or braking. In all tested scenarios where the combination was driven with the coupling disengaged, and where the coupling was disengaged while the vehicle was in motion,

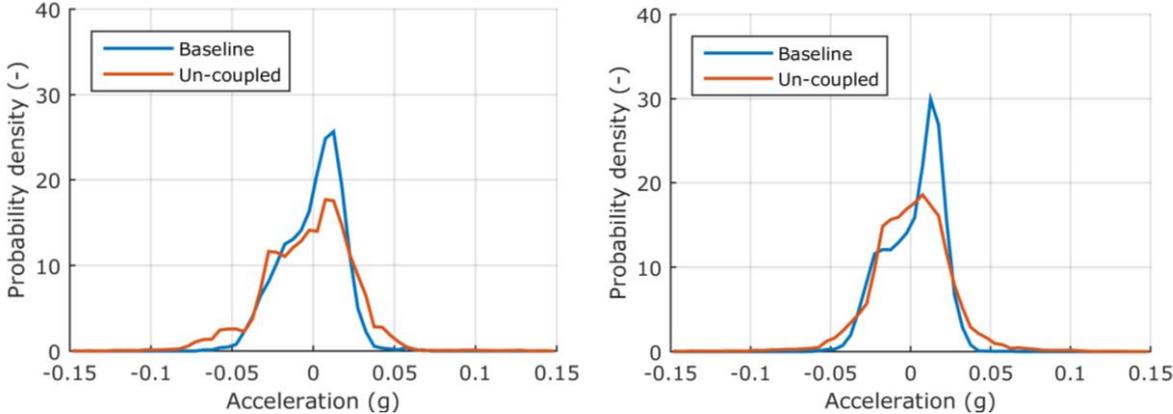
Figure 4 shows the Probability Density Functions (PDF) of the longitudinal accelerations for the truck and trailer in baseline and un-coupled configurations, when travelling at 80 km/h. Comparing the shapes of the density functions provides insights into the relative behaviour of the combination in the baseline and un-coupled scenarios. The plots are very similar in terms of their overall shape, indicating that there is no substantial difference in the range of longitudinal accelerations experienced between the baseline and un-coupled combinations.

The functions for the baseline truck and trailer (i.e. the blue lines) are slightly taller and narrower, indicating that when coupled, the truck and trailer will spend a slighter higher portion of time at very low levels of longitudinal acceleration. In contrast, the functions for the un-coupled truck and trailer (i.e. the orange lines) are shorter and slightly wider, indicating that when connected only by the safety chains, both the truck and trailer are more likely to

experience a wider range of longitudinal accelerations. In practical terms however, these differences are minor, and point towards the only difference between the baseline and un-coupled scenarios being the shunting of the truck by the trailer when un-coupled. The general observations made support this finding.

FIGURE 4 – Probability density functions of longitudinal accelerations for the truck (left) and trailer (right) travelling at 80 km/h

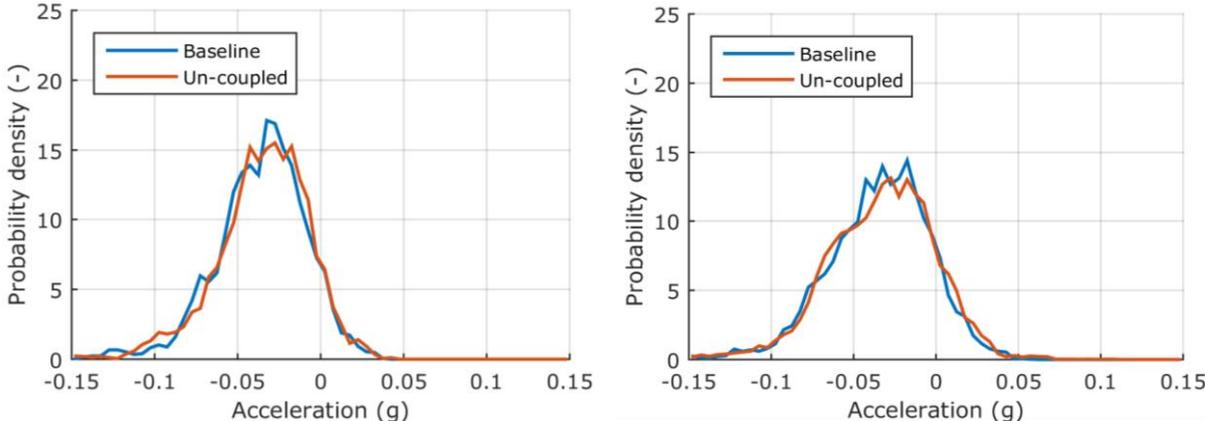
Figure 5 shows the PDF of the lateral accelerations for the truck (left) and trailer (right) of the baseline vehicle and un-coupled vehicle, when travelling at 80 km/h (approximately 50 mph). Again, comparing the shapes of the functions provides insights into the relative behaviour of the trailer in the baseline and un-coupled scenarios.

The key result is that the shape of the functions for the truck and trailer are nearly identical in both the baseline and un-coupled scenarios, indicating that there are negligible lateral acceleration effects for either the truck or trailer as a result of the disconnected coupling, and the observed tendency of the trailer to wander causes a negligible lateral acceleration increase for the truck. Numerical results of Root-Mean-Square (RMS) and peak values for longitudinal and lateral acceleration of the fully laden vehicle are shown in Table 2.

FIGURE 5 – Probability density functions of lateral accelerations for the truck (left) and trailer (right) travelling at 80 km/h

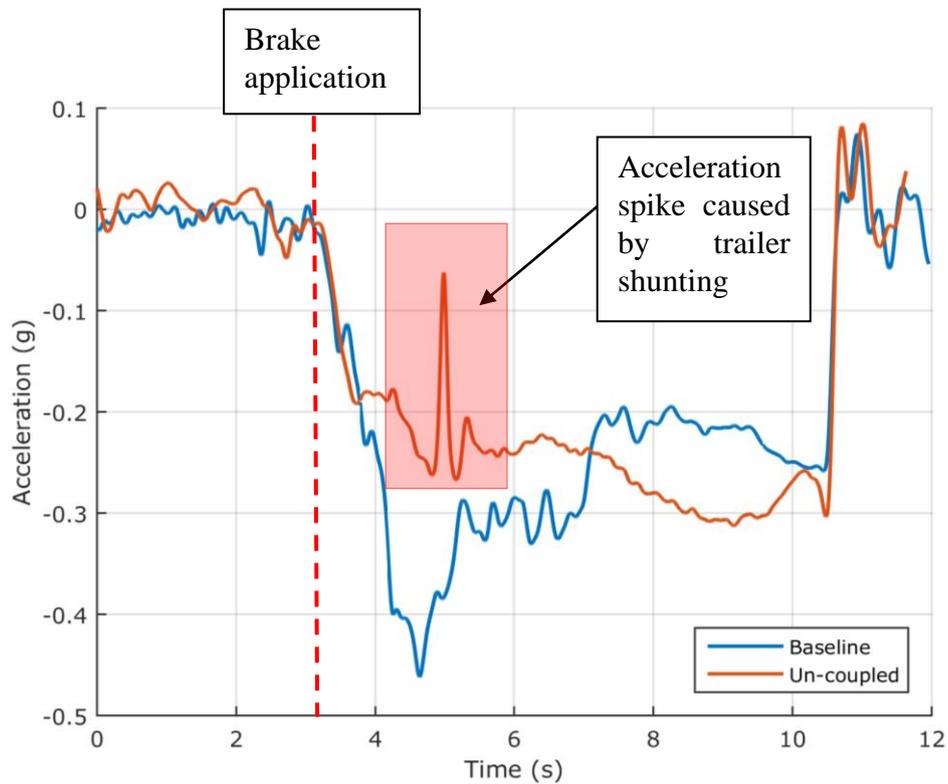
The primary effect on vehicle dynamics when braking from a constant speed was again the tendency of the trailer to shunt the truck from behind, which generally occurred if the chains were either slack, or taut in the rearwards direction when the truck's brakes were applied. Figure 6 shows a plot of the longitudinal acceleration experienced by the truck during a braking manoeuvre, for the baseline and un-coupled scenarios, from an initial speed of 60 km/h. The start of the braking period is annotated.

The baseline vehicle achieves a peak initial deceleration of between 0.4 and 0.5 g, which reduces slightly as the driver modulates brake pedal force and brings the vehicle to a stop. In contrast, the deceleration of the truck for the un-coupled vehicle follows a similar slope, but is interrupted by the shunt from the trailer. This is evident as a positive spike in the acceleration plot, and is annotated by the shaded red box. The lower magnitude of peak acceleration in the un-coupled case is simply a matter of the driver having applied different amounts of brake pressure in different tests.

FIGURE 6 – Truck longitudinal acceleration during braking from 60 km/h

Nevertheless, there were no increases in lateral acceleration or trailer yaw rate as a result of the shunting. This finding supports the observations made by the driver that the shunting action is unlikely to cause the combination to jack-knife under heavy application of the brakes.

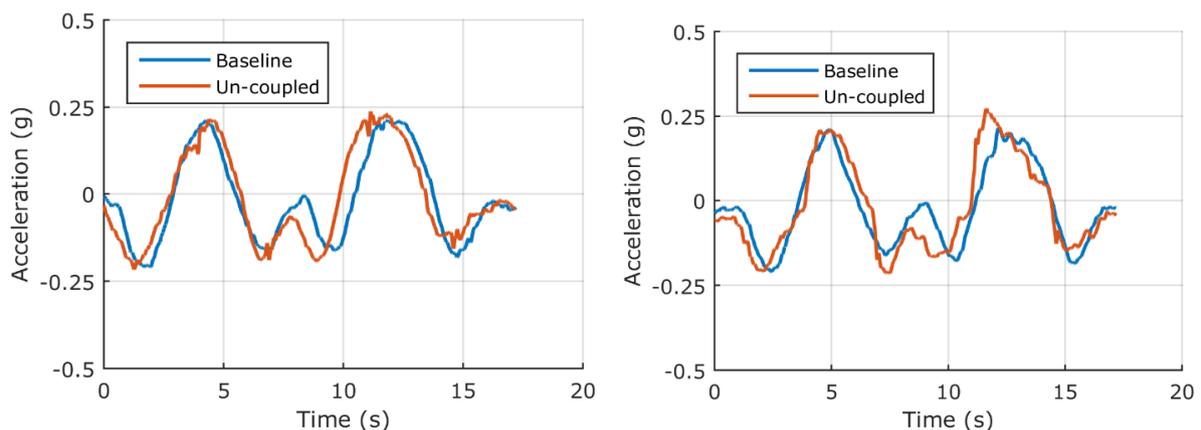
Figure 7 shows plots of the lateral acceleration experienced by the truck and trailer during the swerving manoeuvre, for the baseline and un-coupled scenarios, conducted at 60 km/h. The plots show that the un-coupled trailer experienced a marginally higher lateral acceleration than the baseline trailer during the swerving manoeuvre. This was not identified by the observer group or the driver, as the difference was difficult to discern by eye.

FIGURE 7 – Lateral accelerations for the truck (left) and trailer (right) at 60 km/h

An increase in both peak lateral acceleration and peak yaw rate of the trailer is expected for this type of manoeuvre when the trailer is uncoupled. The magnitudes of the peak values are within the range expected for this type of vehicle in normal operational configuration. A typical truck and dog trailer combination commonly assessed by Advantia under the Performance Based Standards Scheme (1) experiences peak lateral accelerations of more than 0.30 g and peak yaw rates of around 8-13 degrees per second in a standard “lane change” manoeuvre.
