EFFECTS OF VERY LARGE INNOVATIVE HEAVY VEHICLE COMBINATIONS ON PAVEMENT SURFACES

N. TREVORROW
ARRB Group Ltd.
Australia

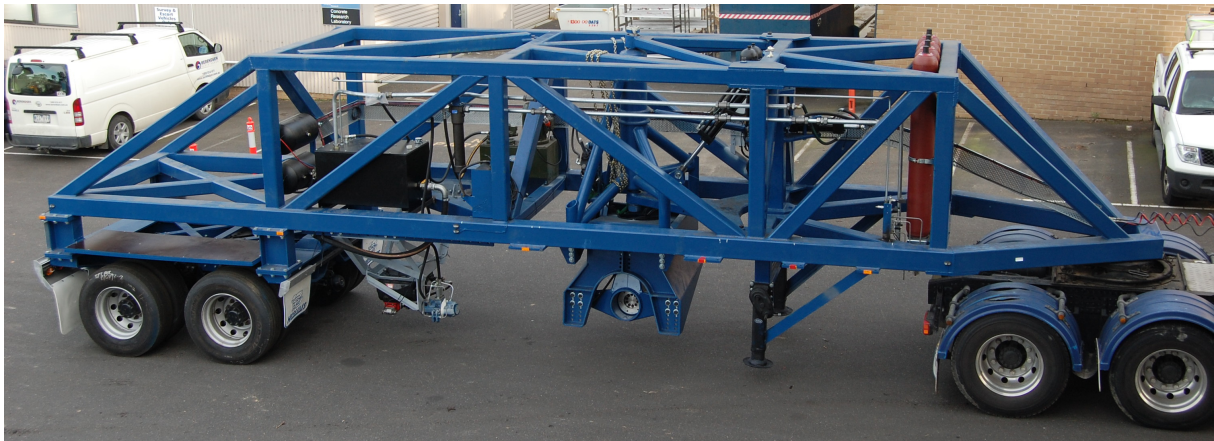
The tyre force and surface wear mobile rig developed (Figure 1) can replicate the forces and therefore stresses applied to the pavement surface by any single or dual tyre from any steer, drive or trailer wheel from any heavy vehicle combination undertaking any manoeuvre in an accurate and most importantly, repeatable manner. If these stresses can be accurately applied and the resulting surface wear accurately measured, a link between the two can be drawn that currently does not exist in the literature.

Figure 1 – Tyre force and surface wear mobile rig

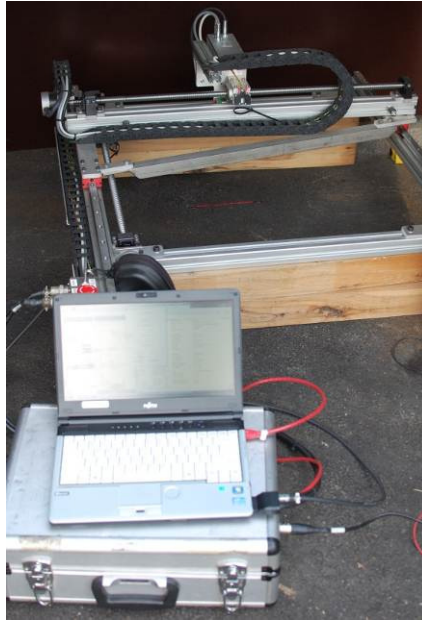
A survey of existing pavement surface wear measurement techniques suggested that few have the capacity to identify and track the movements of individual aggregate particles with a high degree of precision. A surface topography laser rig (Figure 2) was designed and constructed comprising a traversing laser device that can scan the surface and generate data points that can then be imported to, and manipulated by, computer software. This allows accurate measurement of surface wear, especially under aggressive low-cycle loading conditions.

Figure 2 – Surface topography laser rig

The surface topography laser was used to measure the test section lightly-trafficked 3D surface coordinates and post-wear coordinates. The geometry of the three survey spikes, present in each scan, were then used to rotate and translate each set of scanned coordinates, so the difference between them could be analysed, without having to precisely position the laser rig in exactly the same position before and after the surface wear event.

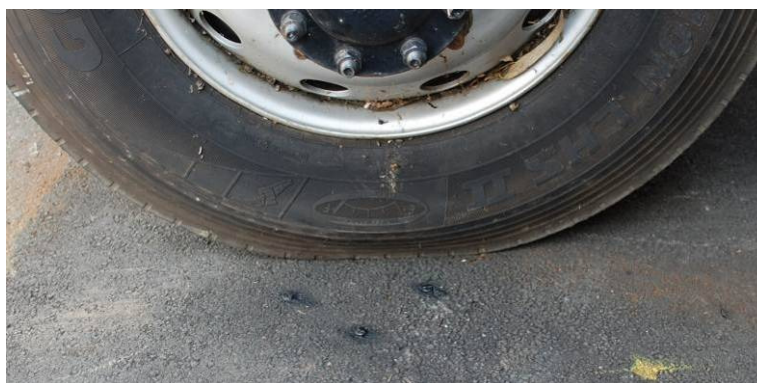
Figure 3 – Test tyre positioned on test section

The single test tyre was positioned to pass through the test section, within 20 mm of the survey spikes, in a location similar to that shown in Figure 3. The test tyre was a drive tread pattern with a vertical load of 1.2 tonnes, inflated to the manufacturer's recommended inflation pressure for the given vertical load, 90 PSI.

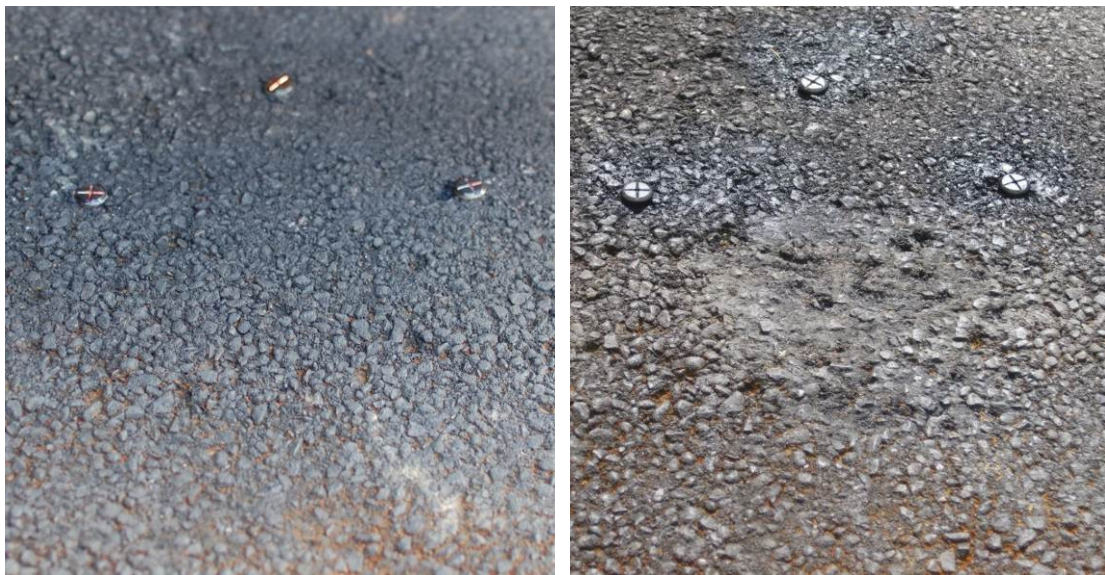
Figure 4 – Lightly-trafficked (left) and post-wear (right) hot mix asphalt surface

It was observed that multiple aggregate particles were plucked from the binder by the combination of horizontal and vertical stress applied to the pavement surface by the test tyre. The majority of these were near the tyre tread shoulder, suggesting this is a region of particularly high relative stress. Many other aggregate particles were sheared relative to their initial position and significant shearing of the binder over the top of the remaining aggregate particles was evident.

The observation that only a single load cycle was required to cause obvious pavement surface wear supports anecdotal evidence that failure mechanisms particular to the pavement surfacing layer can be present under low-cycle (< 10) loading conditions. In addition to the new surface wear measurement and analysis technique, a common approach of analysing photographs was also undertaken. Figure 4 shows the lightly-trafficked and post-wear surface characteristics.

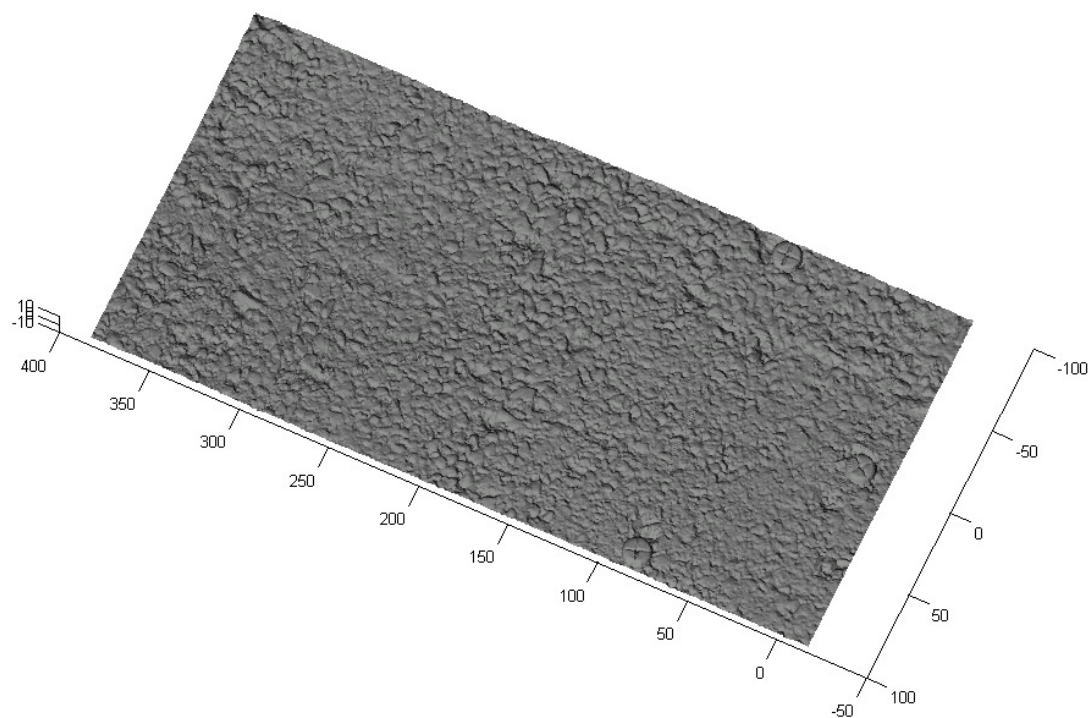
The lightly-trafficked and post-wear laser scans can be seen in Figure 5 and Figure 6 respectively (coordinates are mm).

Figure 5 – Lightly-trafficked hot mix asphalt pavement surface before testing

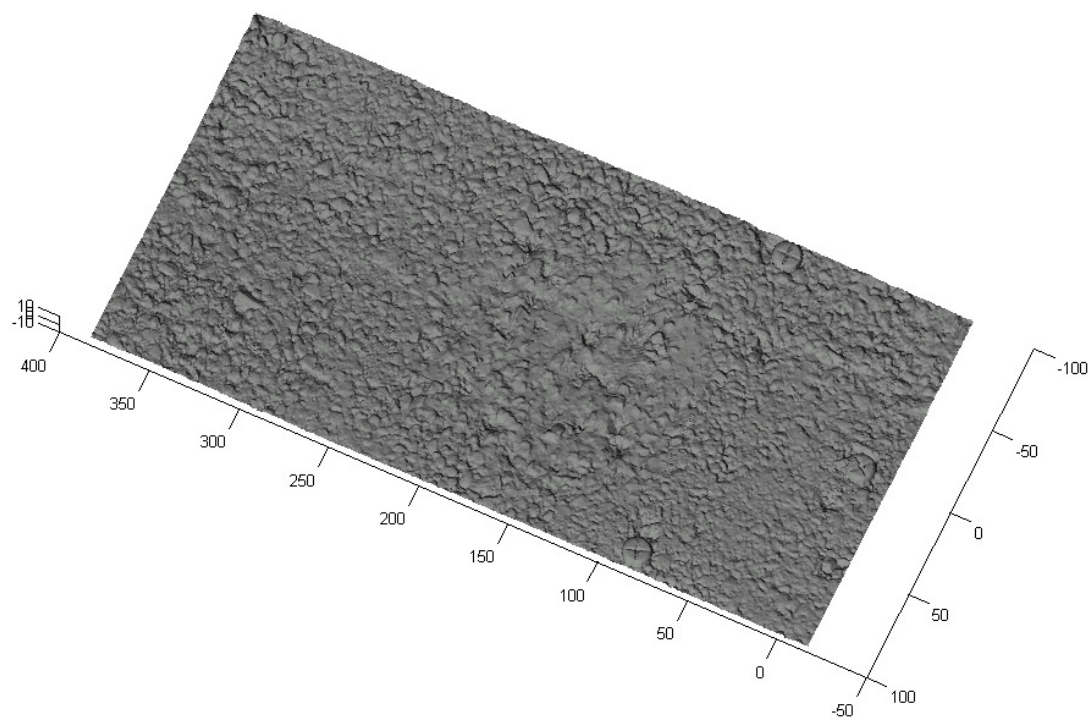
Figure 6 – Post-wear hot mix asphalt pavement surface

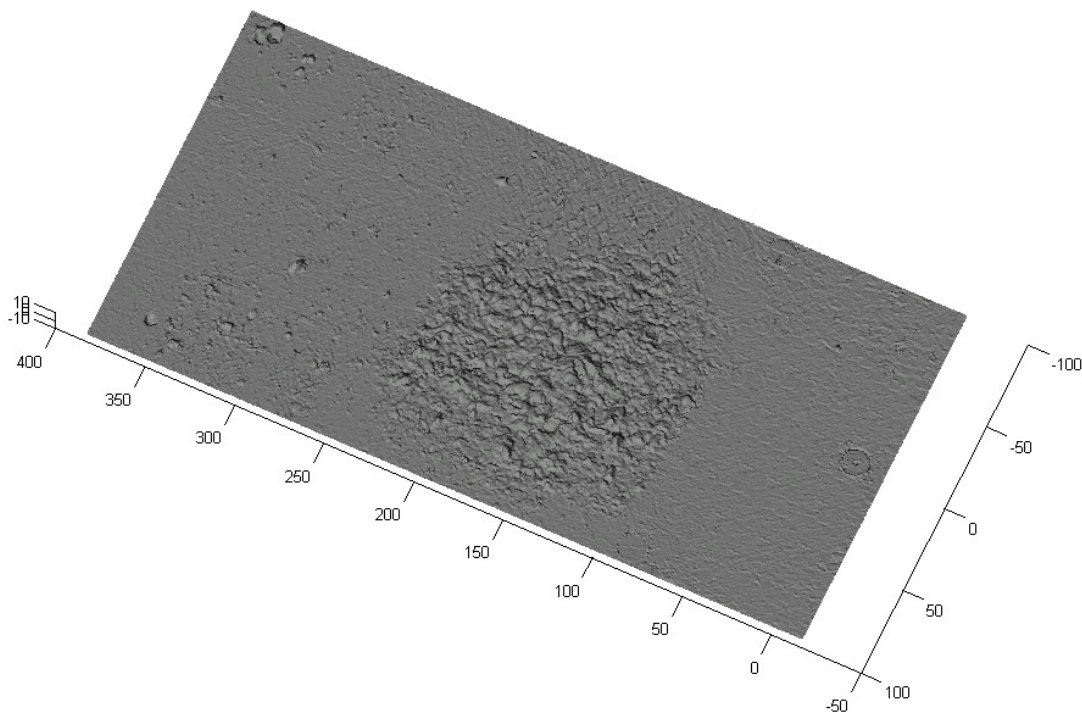
The wear analysis technique developed during the project involves comparing differences between the unworn and post-wear 3D surface coordinates of a test section. The scan horizontal coordinates are synchronised by rotating and translating the coordinates until the centres of each of the three survey spikes are aligned. The changes in surface characteristics are then determined by subtracting the post-wear scan vertical coordinates from the lightly-trafficked scan. Hence, if an aggregate particle is removed, it will appear in Figure 7 in its positive form in its original location, against a flat (unchanged) background.

Figure 7 – Subtraction of lightly-trafficked scan from post-wear scan

By undertaking wear analysis in this manner, it was noted that several aggregate particles were removed from the top and left of the test section, possibly due to scrubbing forces when positioning the test tyre which took up to five attempts. This wear went unnoticed during visual and photographic analysis. Detailed analysis revealed 18 aggregate particles were plucked from the binder and a further 35 were sheared relative to their original position by the combination of horizontal and vertical stress applied to the pavement surface by the test tyre. Significant binder shearing over the top of remaining aggregate particles in the direction of gross contact patch horizontal force was observed in a section measuring 115 mm by 130 mm.
