Transverse Cracking Distress and Vertical Dynamic Impact Load From Heavy Truck Axles - A Feasibility Study

George J. Chong
Research and Development Branch

Ministry
of
Transportation

Research and
Development
Branch

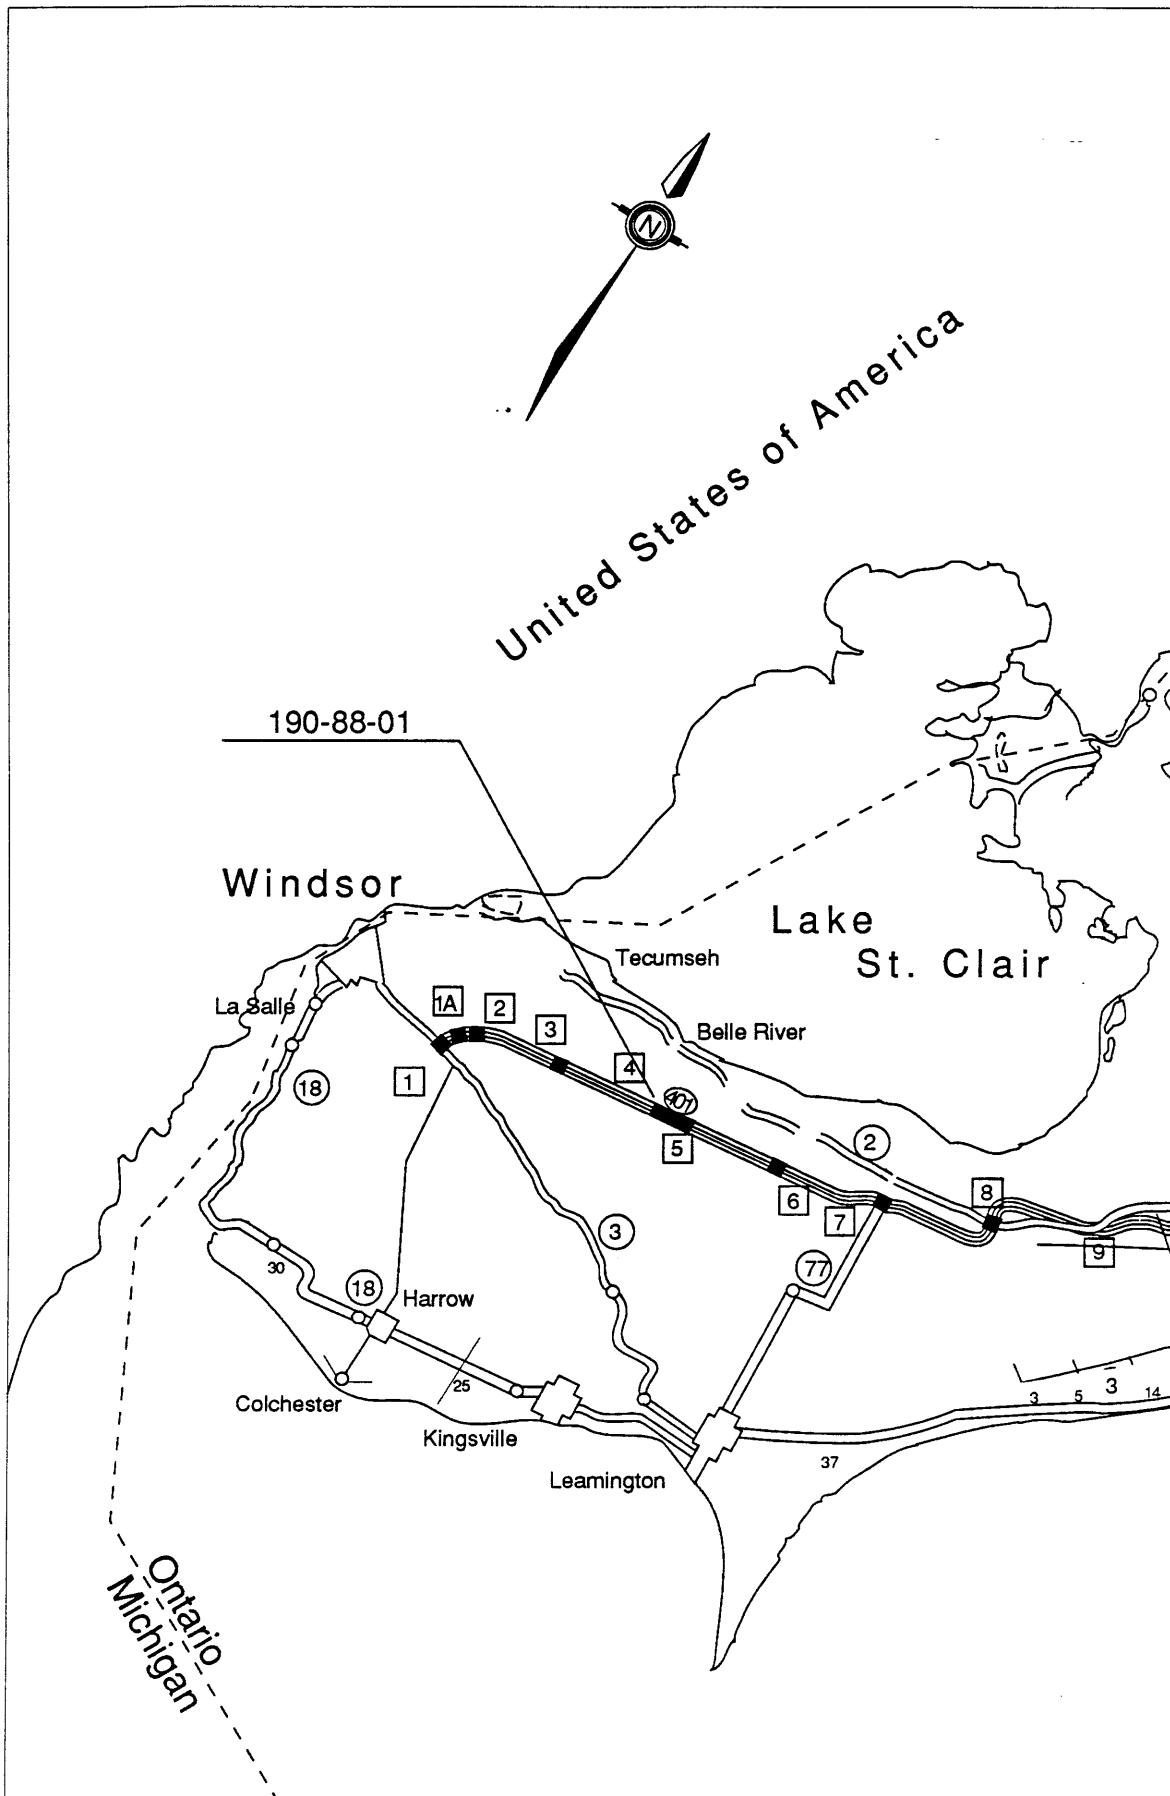
Figure 3/ Experimental Site on Highway 401

The experimental site chosen by the Regional Geotechnical Office was located on the westbound lanes of Highway 401 between Tilbury and Windsor (Figure 3).

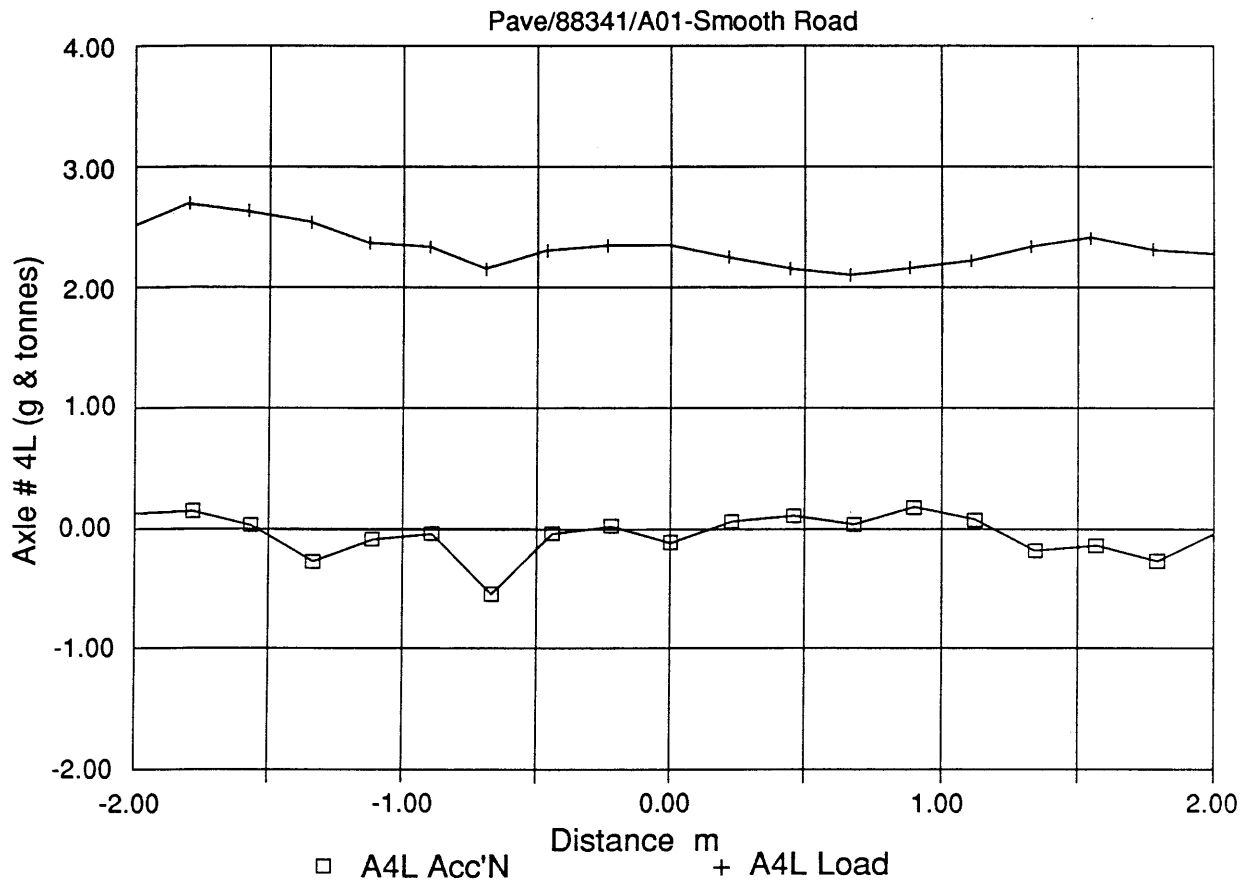
Figure 12/ Crack Study, Highway # 73 S/B, South of 401

Inspection of graphs Figure 9, crack 4, (slight); Figure 10, crack 7 (moderate); figure 11, crack 9 (severe); Figure 12 (smooth road) and Table 2, show that there were distinct differences between slight and severe cracks (cupping). Those described as slight by the core and visual survey, exhibited an initial negative or downward acceleration of approximately -1.0 g followed by a positive or upward acceleration of up to 1.6 g. Moderate cracks had slightly larger downward values and positive accelerations of up to 1.9 g. Severe to very severe had upward values between 2.0 and 4.0 g respectively. Smooth road conditions had values between +/- 0.5 g. In all cases cupping was characterized by a negative followed by a positive axle acceleration.
